Sub: Review of Outcome of Third Party Audit of Railway Bridge/ROBs/FOBs

Sub: Technical Report on repeated failure of vertical in 91.5M K Type truss of Bridge no-57 (Down) in Kharagpur Division of S. E. Rly.

REPORT ON THE CRACKS & DEFECTS IN DIFFERENT MEMBERS OF OPEN WEB THROUGH TYPE K - SHAPE GIRDER OF BRIDGE NO. 57 (7X300'0''G+4X100'0''G) AT KM: BETWEEN KOLAGHAT (KIG) & DEULTI (DTE) STATIONS OF KGP DIVISION

**TECHNICAL REPORT ON FAILURE OF
BRIDGE NO. 57 OF S.E. RAILWAY**

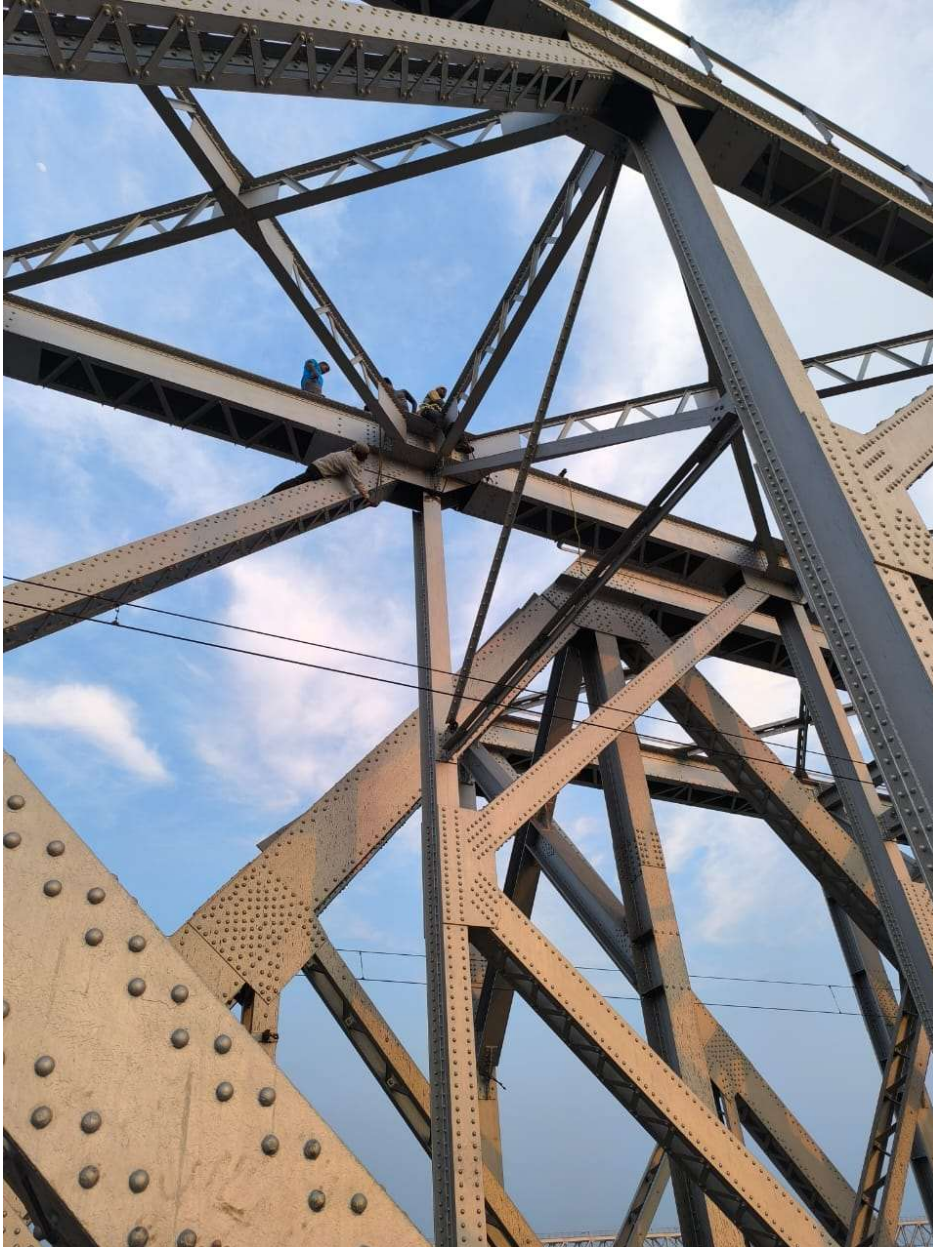
3.0 Cracks were noticed in the 2nd vertical U_1M_1 (upper) at the joint ' U_1 ' of span no.5 of 300feet girder by Sri Prasenjit, BRI staff under SSE/Br/KIG /SER at about 13:00 hours.Immediately 20kmph was imposed.The details are as shown:-

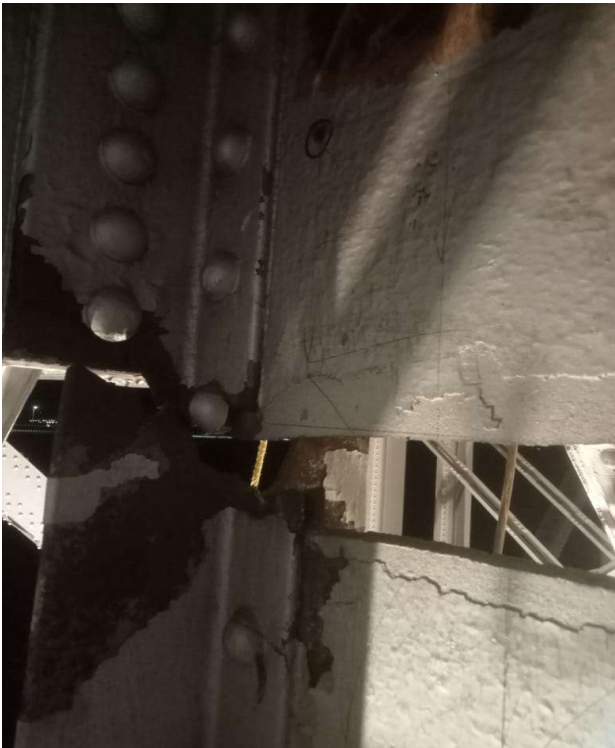
GAP OF 65mm OCCURRED IN THE VERTICAL

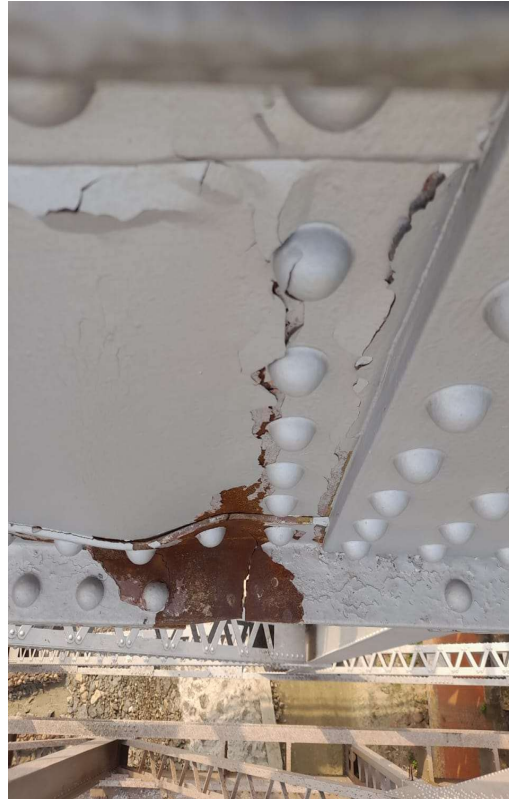
WARPING OBSERVED IN THE WEB

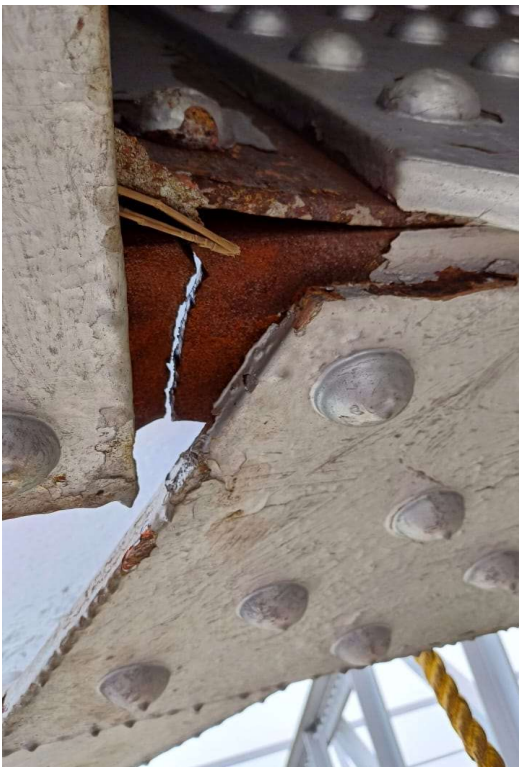
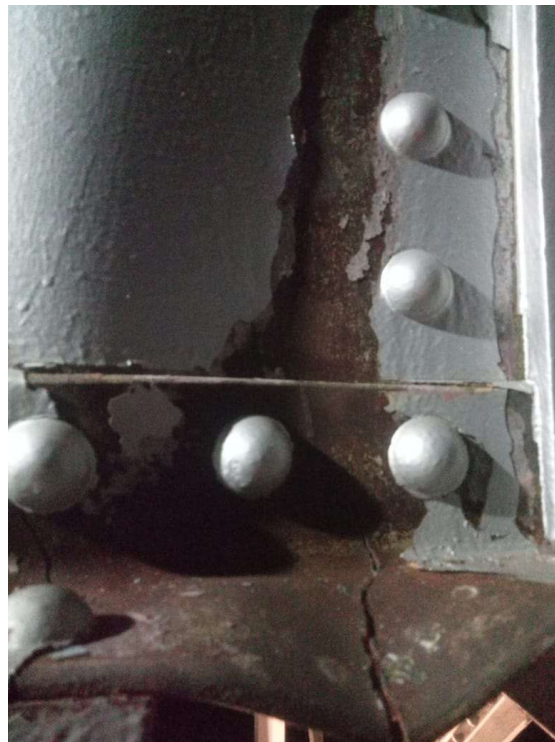
CRACKS AT JOINT "U1"

6.0 Theoretical analysis done and it is observed that vertical, being the tension member probably cracked suddenly due to fatigue resulting into severe distortion in the top chord members at the joint 'U₁'. Diagonal member at this joint is compression member. No irregularity /defect was noticed on the diagonal member at U₁ joint

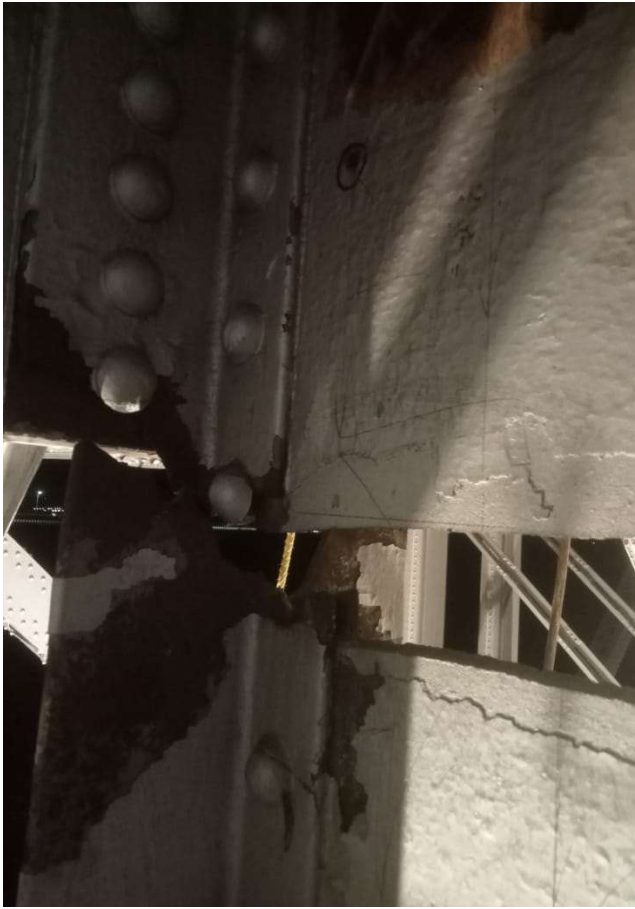
GAP OCCURRED IN THE VERTICAL

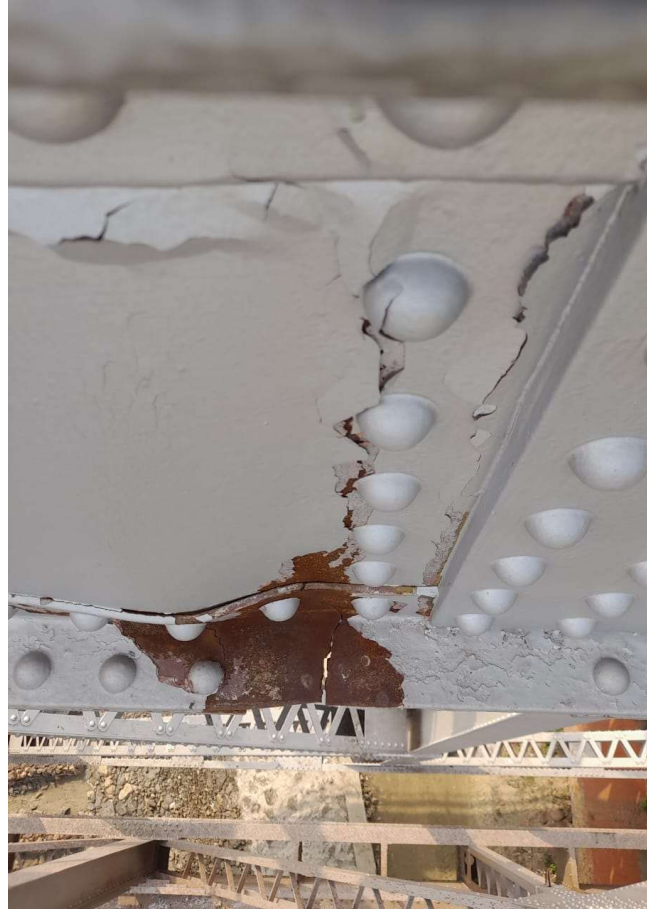
WARPING OBSERVED IN THE WEB

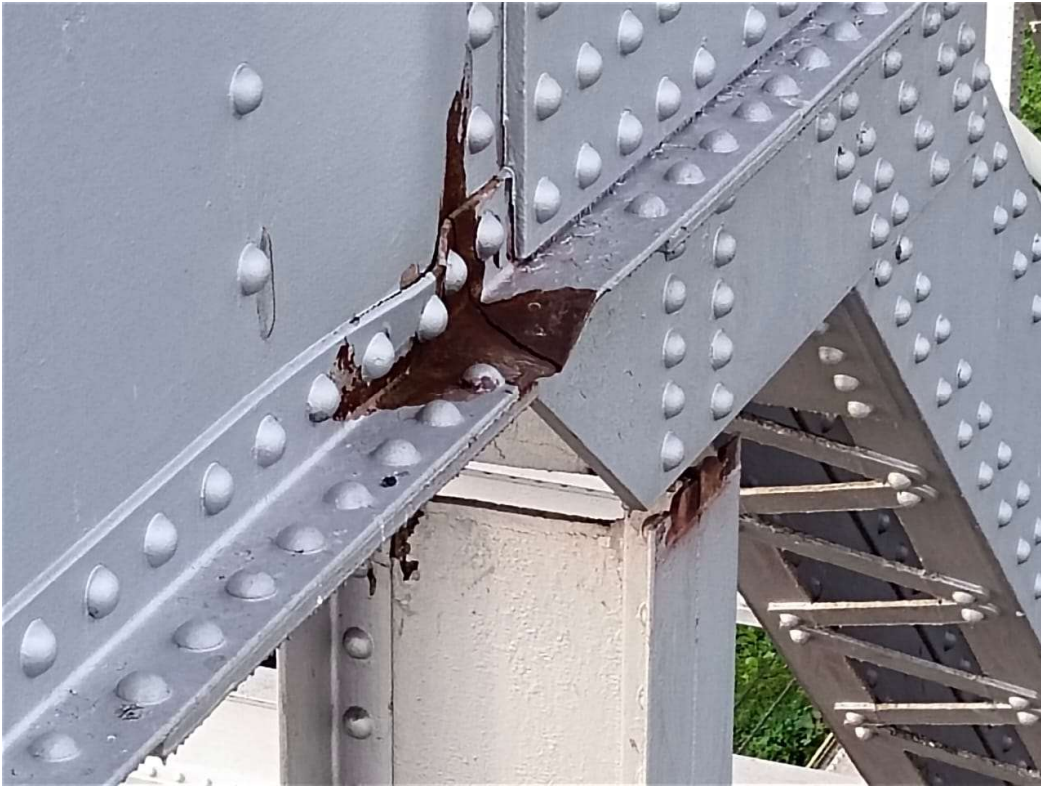
DISTORTION IN THE TOP CHORD MEMBER

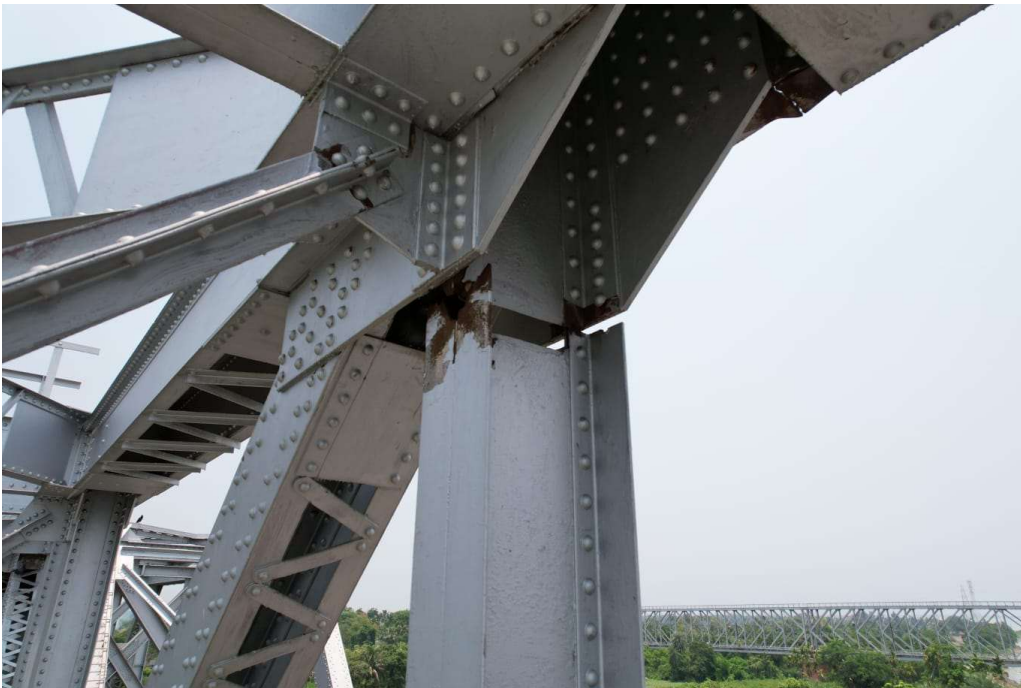
SEPARATION OBSERVED IN VERTICAL

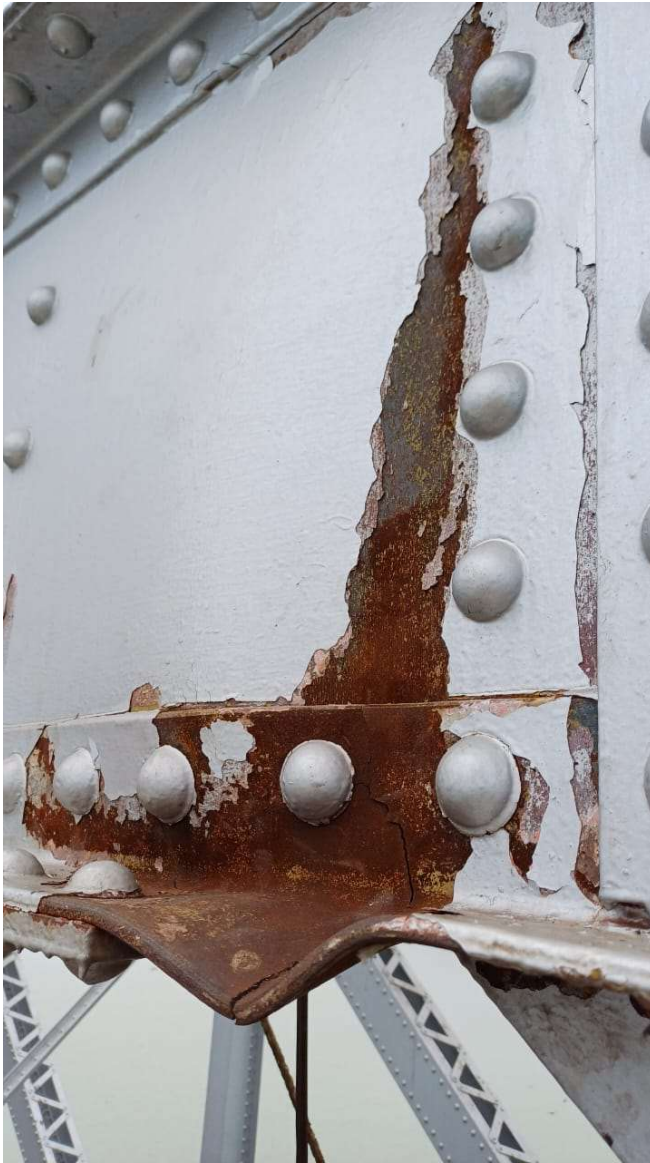
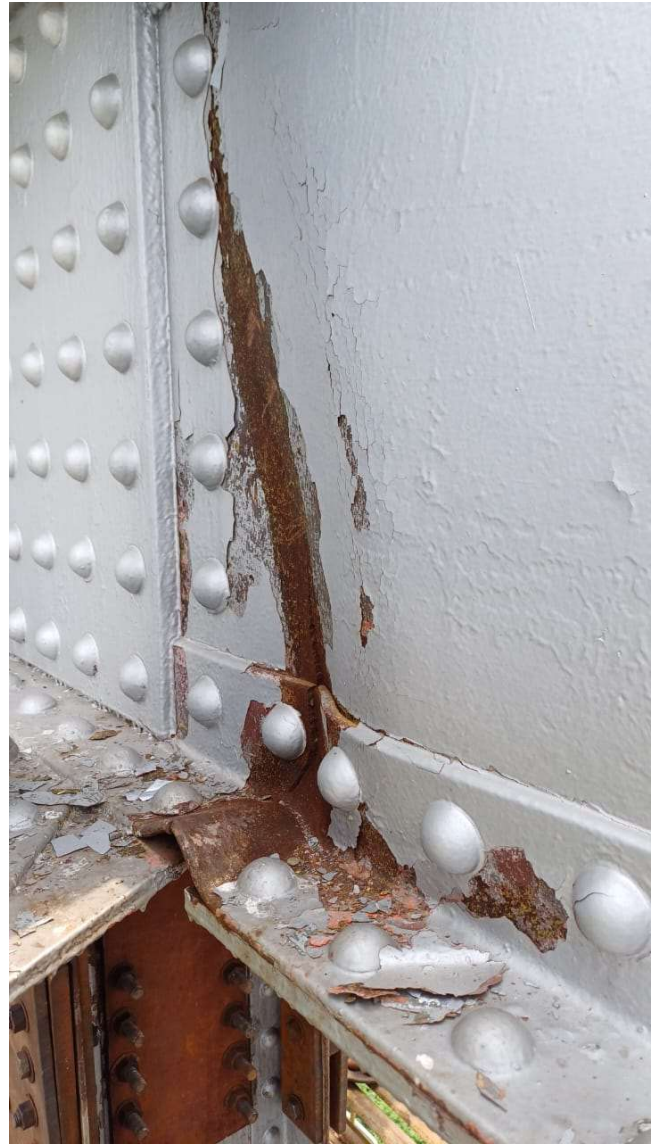
WARPING IN TOP CHORD WEB/ANGLE

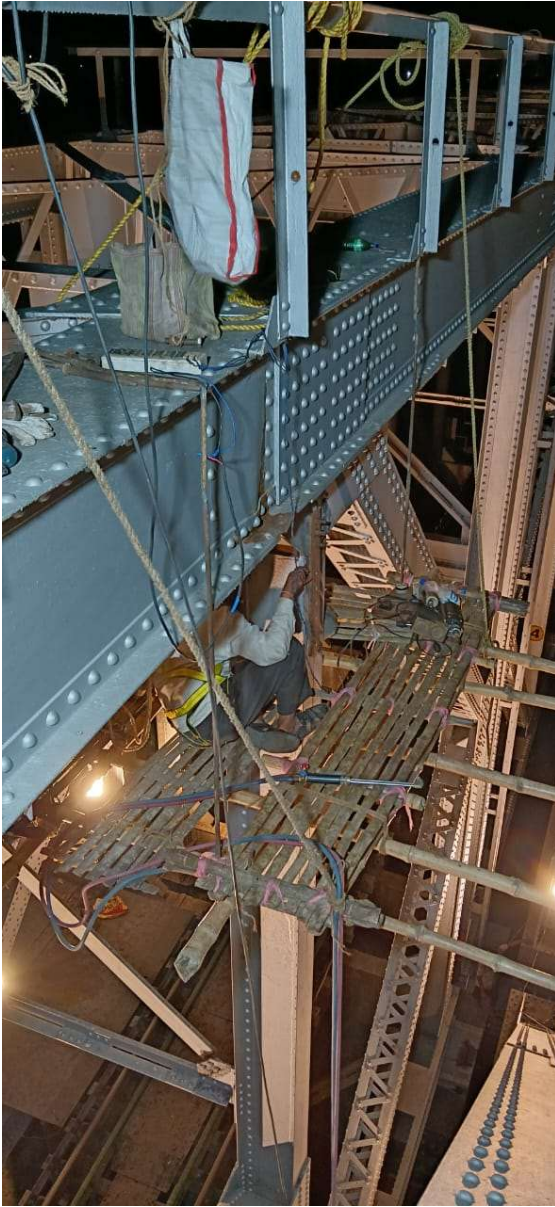
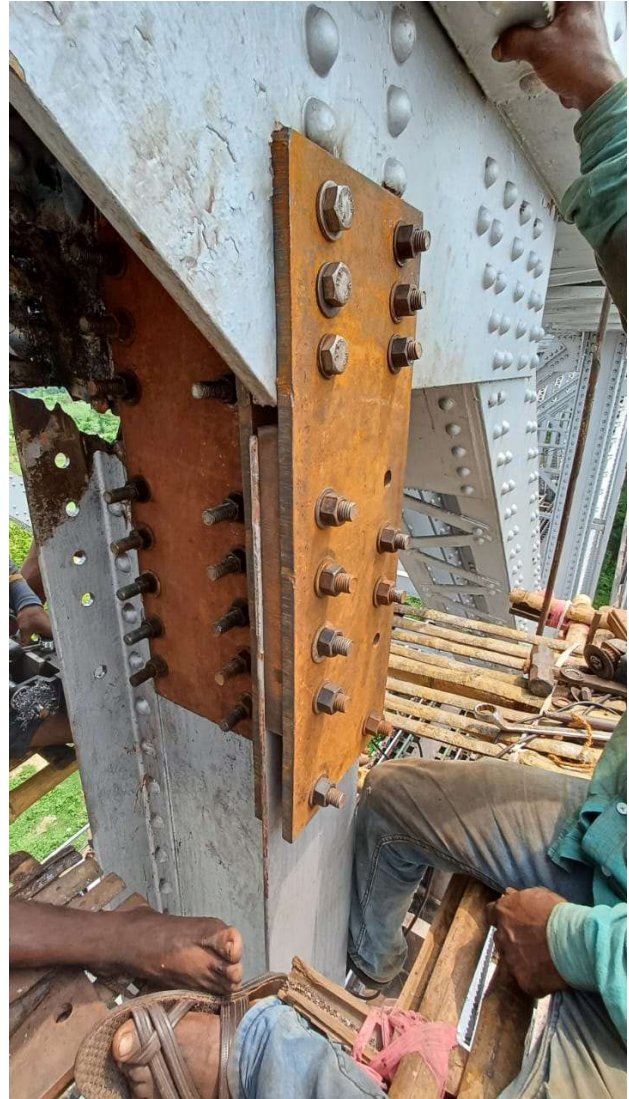
REPAIRING IS IN PROGRESS

4.0 Strengthening done immediately on 17.05.2024 by temporary splicing. The details are as follows:-

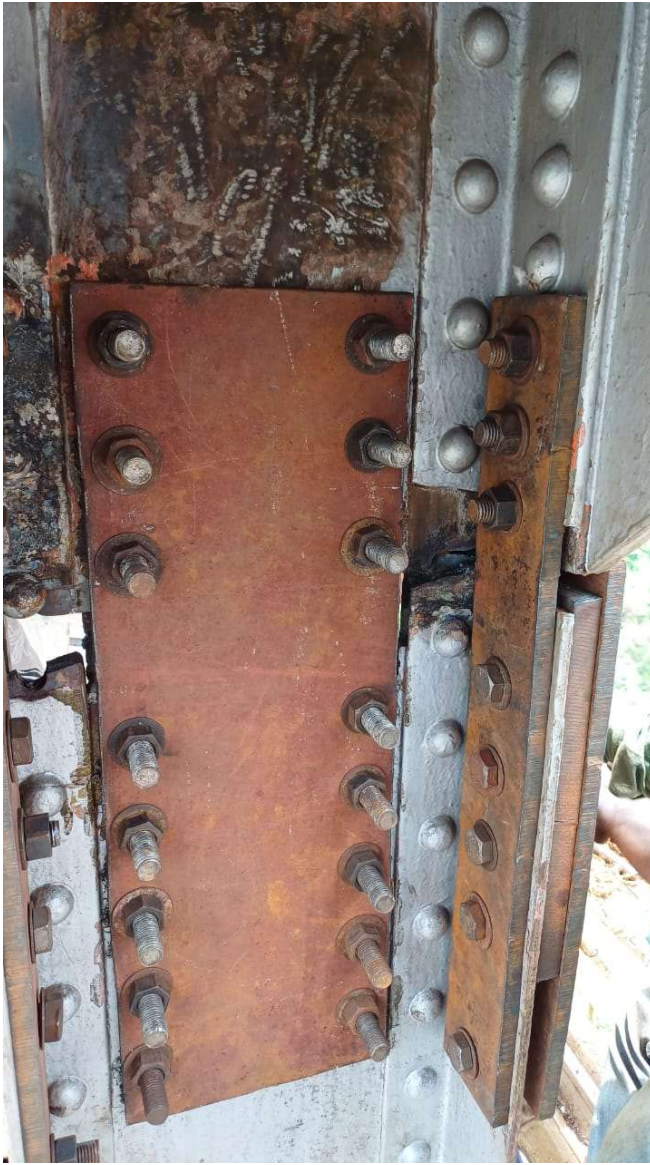
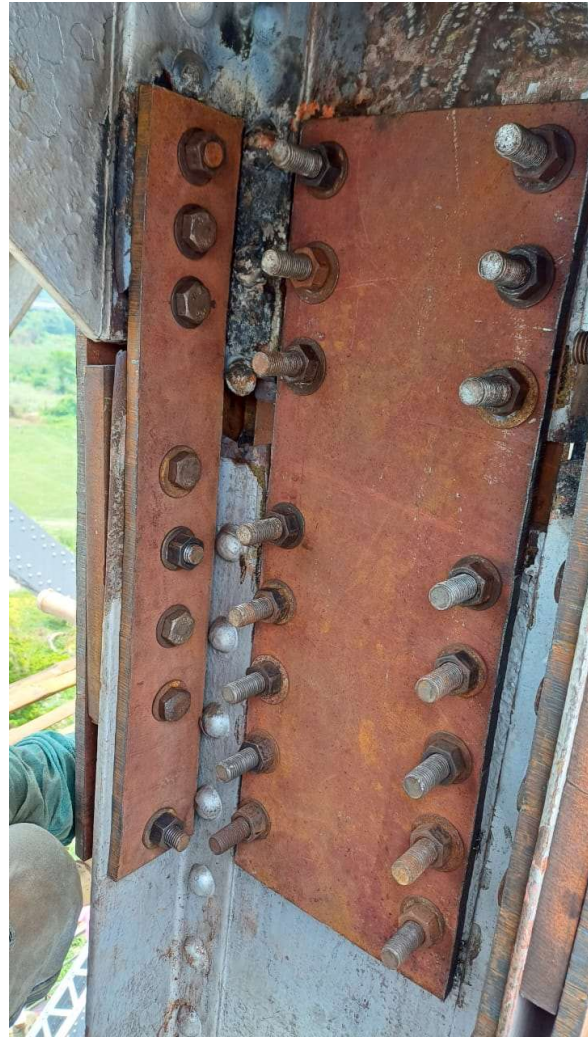
REPAIRING DONE BY SPLICING AND BOLTING

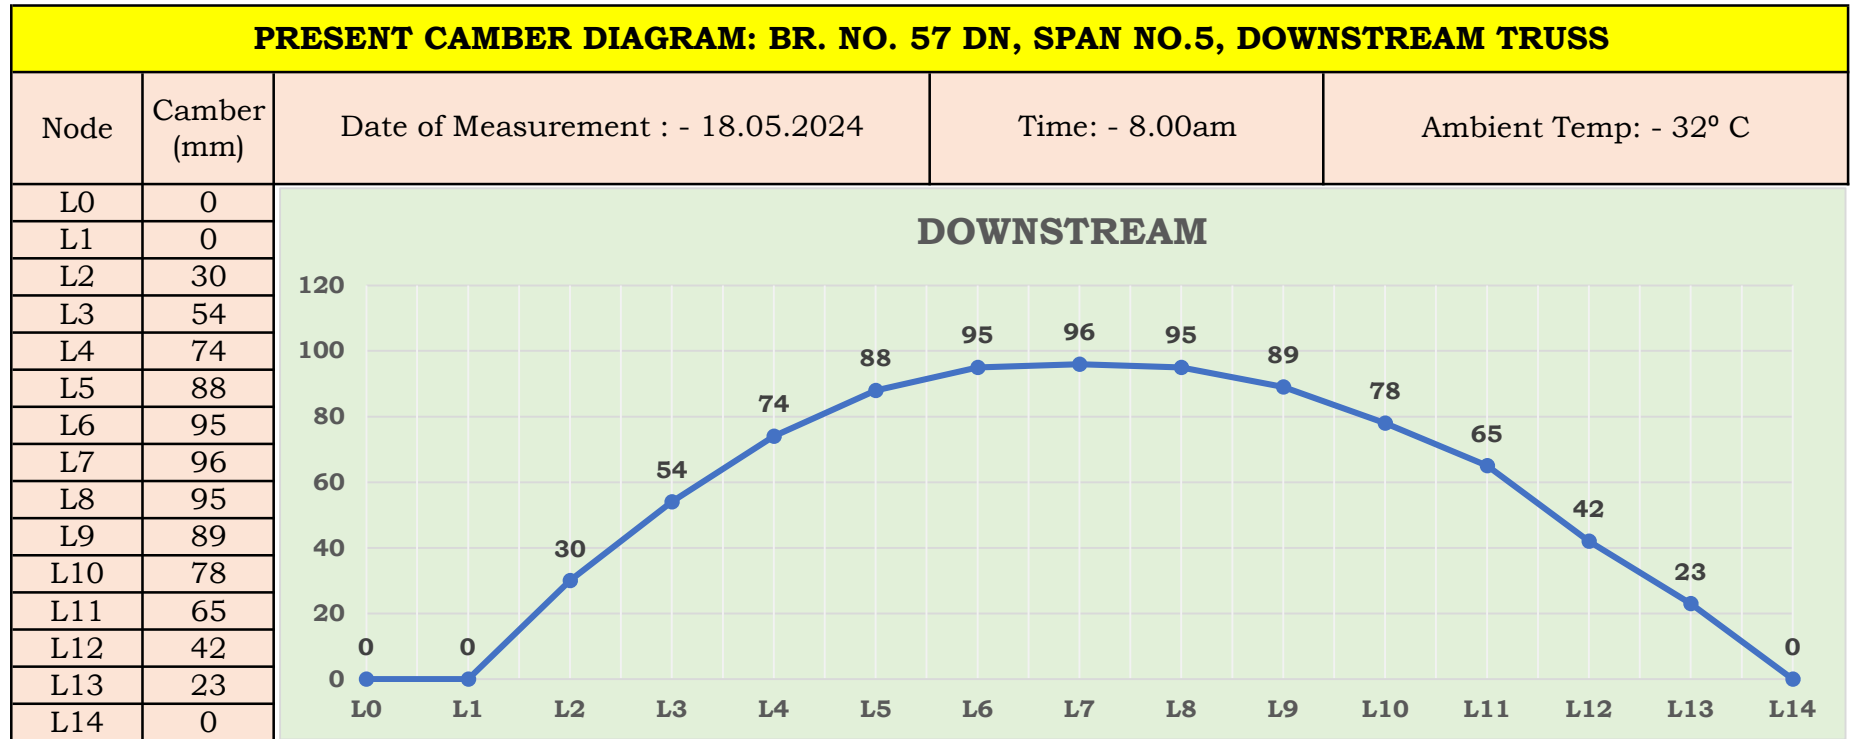
7.0 Camber of the downstream truss has been measured. It is observed that L1 node, corresponding to the cracked U₁-M₁-L₁ vertical has lost its camber. Camber Diagram of the downstream truss is furnished at Annexure-1

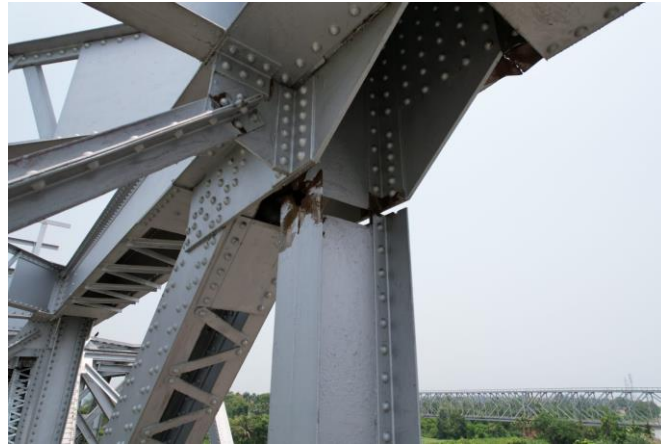
2.1 SER vide letter No. BR/CBE Cell/ dated 21.05.2014 reported structural distress in the Bridge No 57 DN. Cracks were noticed on Second Vertical U1M1(Upper) near U1 of span no. 5 (91.4m span) by BRI staff on 17.05.2024. A gap of approximately 65mm was reported at the location of crack in U1M1.

Fig.1: Full crack near U1 Node in the line of the last rivet (from Top) in Vertical & Gusset Connection.

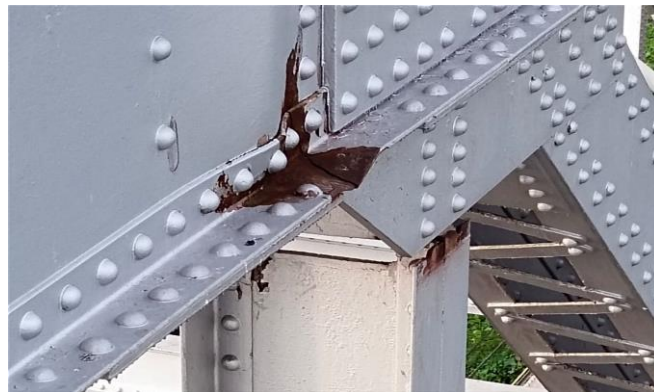
Also in the attached top chord component U1-U2, both the Top Chord Bottom Flange Angles were found having cracks. Both Web Plates were partially cracked. Web Plates & Bottom Flanges angles were bulged.

Fig.2: U1-U2 member

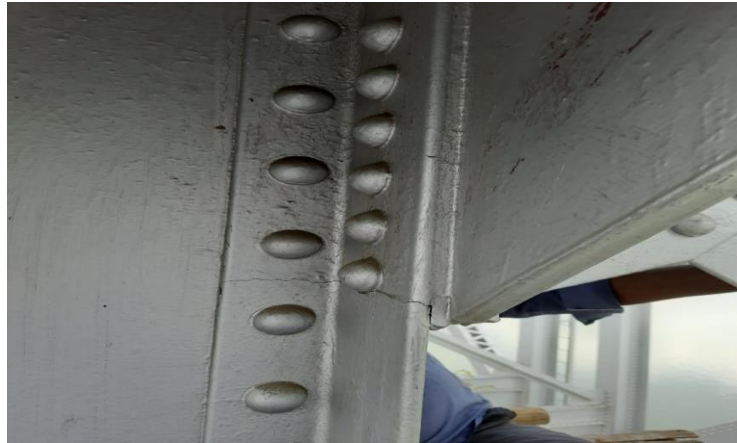
- 2.2 Subsequently on 22/23.05.2024 RDSO team visited the site. On 23-05-2023 further cracks were observed by SER bridge team in another vertical U13-M13 (Upper) at similar location. One (out of the four) Flange angles ISA 125x75x8 was found having crack in both the legs of the angle (Track side, HWH end). Length of crack was approx. 200mm

Fig.3: Vertical U13- M13 D/Stream

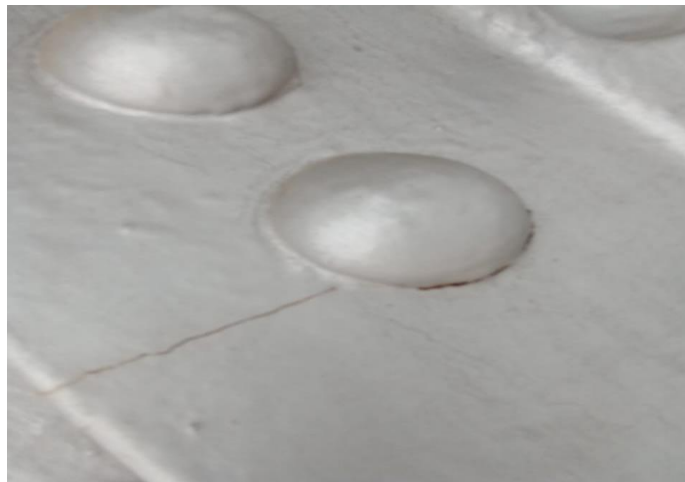
- 2.3 RDSO officials again visited the site on 31-05-2023 in compliance to Railway board letter No.2016/52/CE-III/BR/safety dated 24.05.2024.
- 2.4 During further through inspections by SER team, more cracks were detected. On 01.06.2024 in vertical U13-M13 (upstream), near U13 node in the line of the last rivet (from top) in vertical and gusset connection one (out of the four) Flange angles ISA 125x75x8 was found cracked at 125mm leg of the angle (Outer side, HWH end). Length of crack was 45mm.

Fig.4: Vertical U13-M13 U/Stream

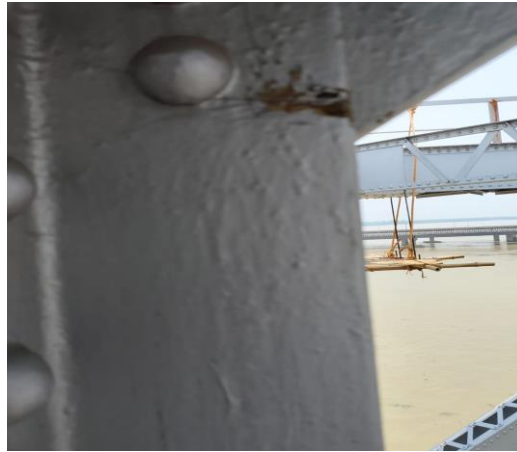
- 2.5 On 07.06.2024 in vertical U13-M13 (downstream), near U13 node in the line of the last rivet (from Top) in Vertical & Gusset Connection One (out of the four) Flange angles ISA 125x75x8 was found cracked at 125mm leg of the angle (Outer side, HWH end). Length of crack was 100mm.

Fig.5: Vertical Chord U 13-M13 D/ Stream

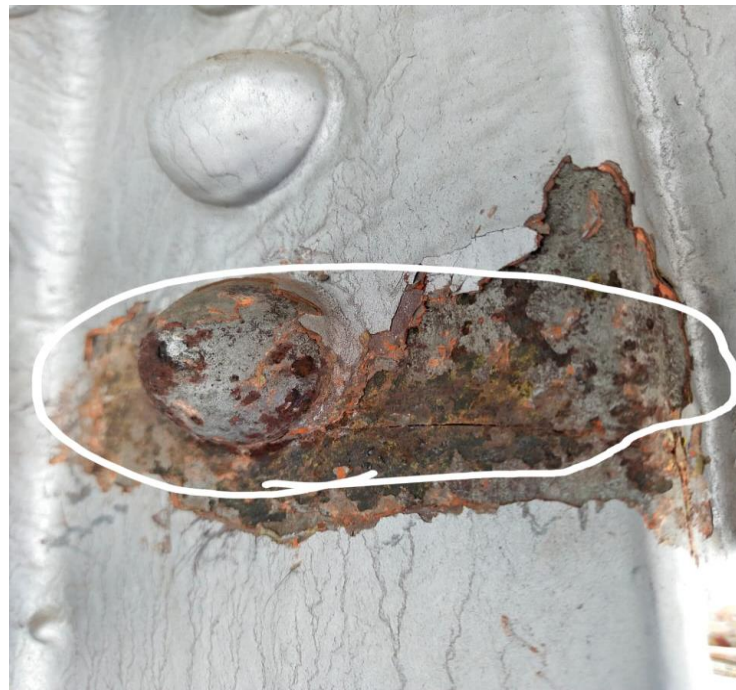
- 2.6 Near U13 node in the line of the last rivet (from Top) in Vertical & Gusset Connection one (out of the four) Flange angles ISA 125x75x8 was found cracked at 125mm leg of the angle (Outer side, HWH end). Length of crack was 60mm.

Fig.6: Vertical U13 - M13 U/Stream

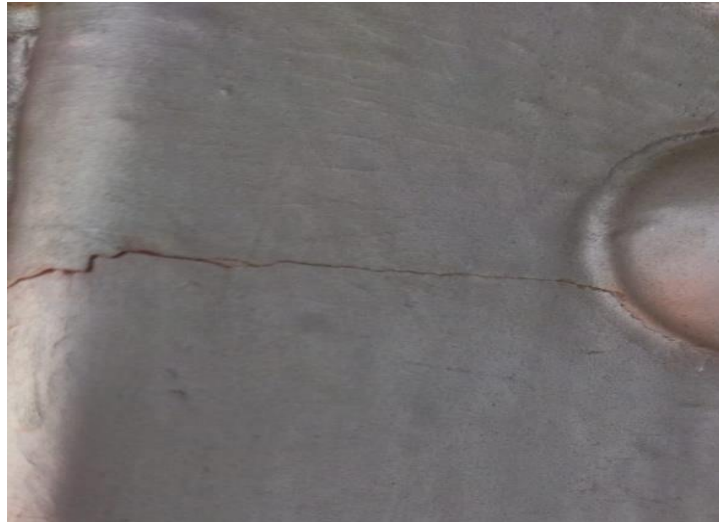
- 2.7 on 08.06.2024 near U1 node in the line of the last rivet (from Top) in Vertical & Gusset Connection one (out of the four) Flange angles ISA 125x75x8 was found cracked at 125mm leg of the angle (Outer side, KIG end). Length of crack was 100mm.

Fig.7: Vertical U1 - M1 U/Stream

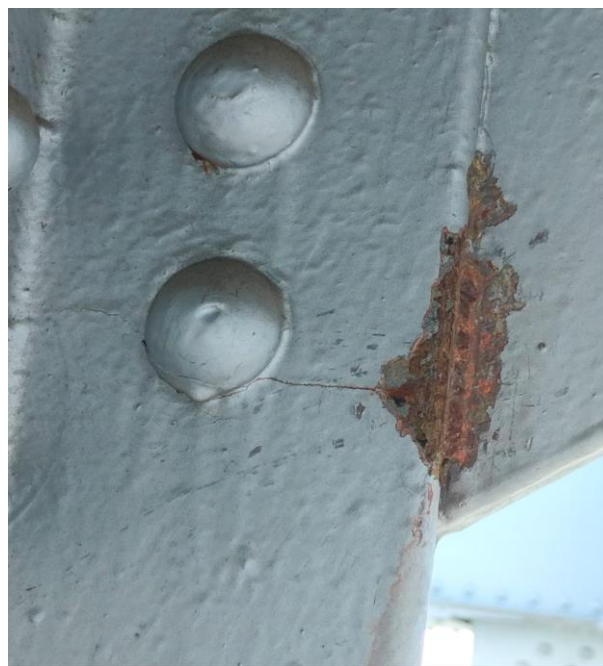
- 2.8 On 10.06.2024 near U11 node in the line of the last rivet (from Top) in Vertical & Gusset Connection one out of the four Flange angles ISA 125x75x8 was found cracked at both the legs of the angle (Track side, HWH end). Length of crack was 115mm. Intermittent/ Tack in-situ weldings were found at Vertical & Gusset Connection.

Fig.8: Vertical U11 - M11 D/ Stream

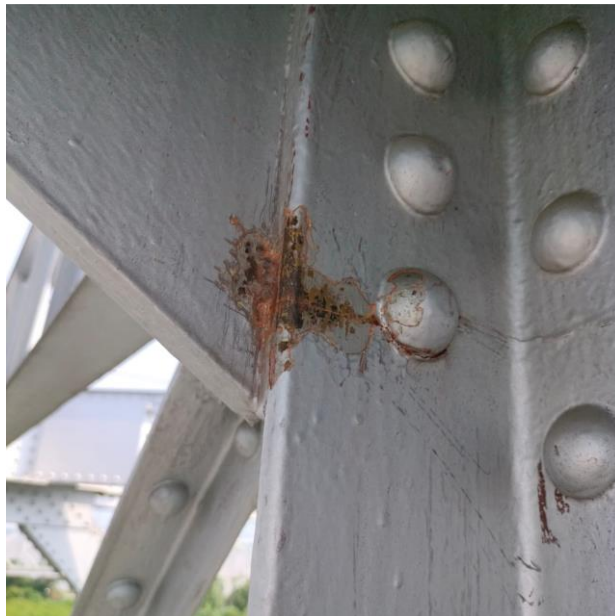
- 2.9 On 11.06.2024 near U11 node in the line of the last rivet (from Top) in Vertical & Gusset Connection one (out of the four) Flange angles ISA 125x75x8 was found cracked at both the legs of the angle (Track side, HWH end). Length of crack was 200mm. Intermittent/ Tack in-situ weldings were found at Vertical & Gusset Connection.

Fig.9: Vertical U11 – M11 U/ Stream
