Sub: En-route detachment of Brake Van

Sub: En-route detachment of Brake VAn no. BVZI - 86381200017 at BWN Up Yard, RL-5 at HWH Division from train no. UP EC 32975 BCN/Ld/BXR on 13.01.2024.

विषय: Failure of Center Pivot pin of BVZI wagon.

Sub: Metallurgical Investigation of fractured Center Pivot Pin of BVZI type Brake Van.

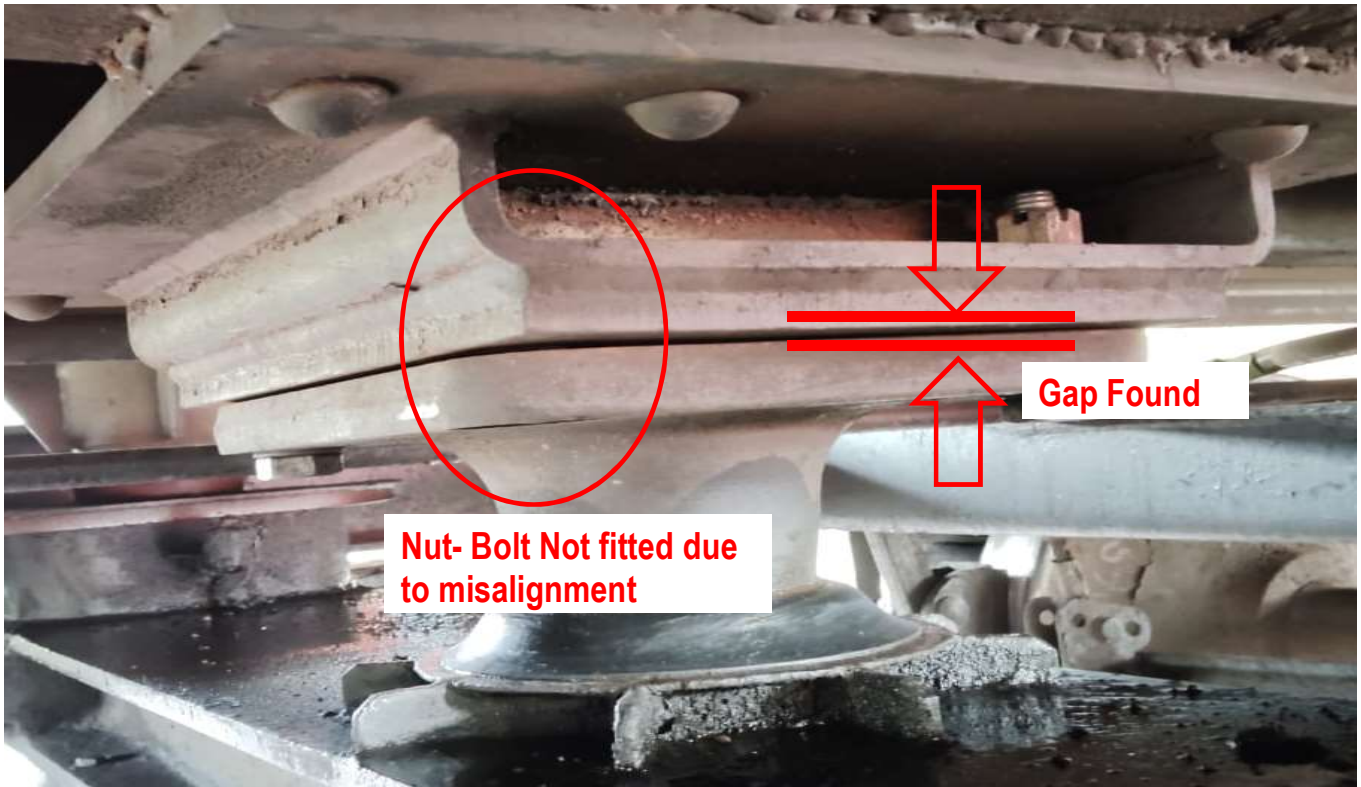
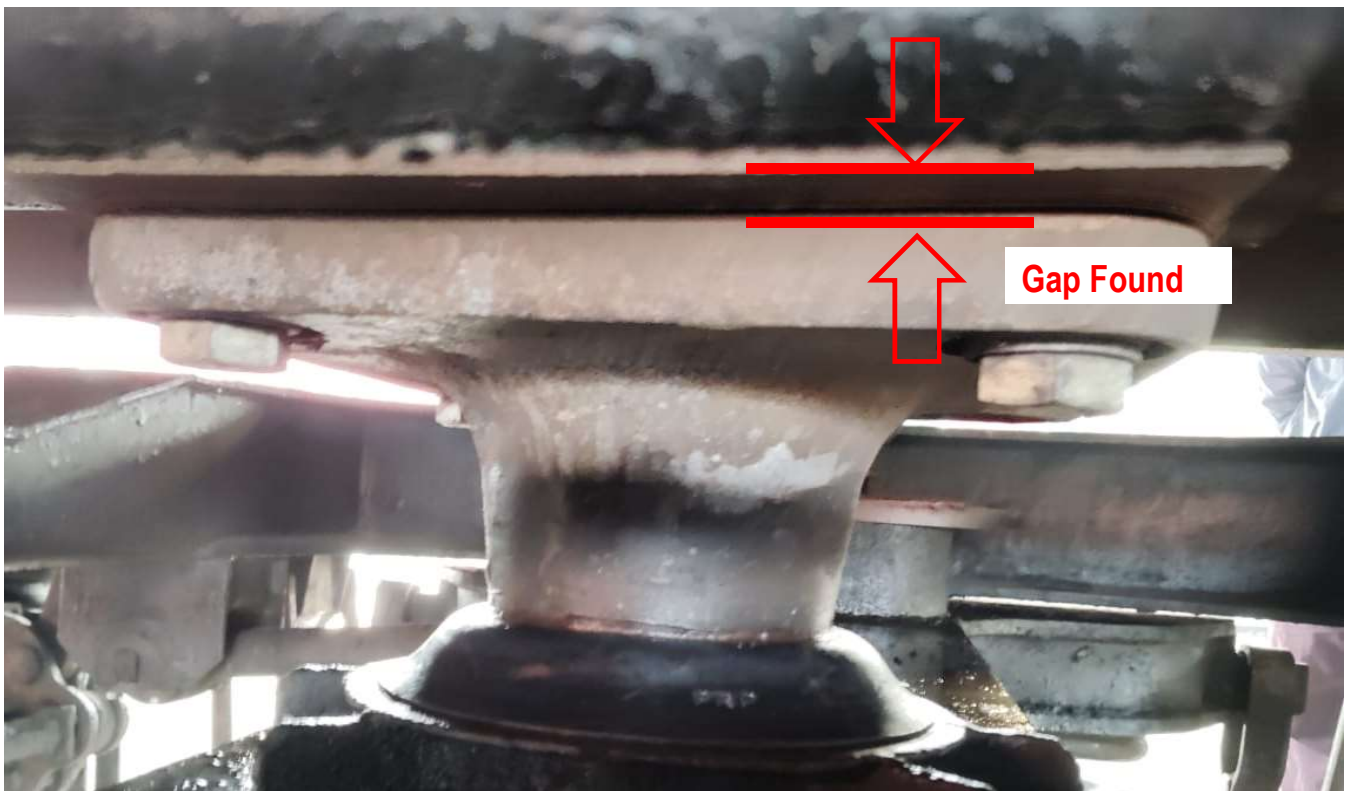
Center Pivot Failure Zone of BVZI at BWN dated 13.01.24

1. One No center pivot nut bolt at DLI end trolley found missing.
2. Found gap between centre pivot bottom and top structure in DLI end trolley.
3. Found misalignment between bottom and top structure due to which Nut –Bolt cannot be inserted in DLI end trolley.
4. Found no tack welding between the bottom and top structure of CP and no tac welding in CP nut & bolt in DLI end trolley.
5. Locking plate of pivot nut in also missing.
6. B clearance only 04 mm.

Two weeks safety drive has been launched to ensure availability of CP nut bolt with tack welding and proper fitment of top and bottom center pivot over Eastern Railway.

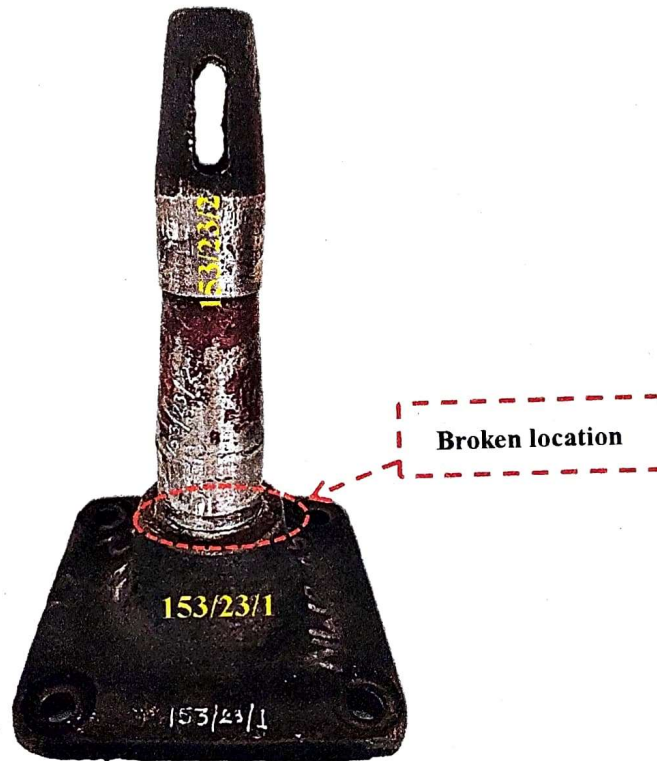
Visual examination revealed that Centre Pivot Top Pin had broken transversely from the transition zone (zone at which diameter change) into two pieces (**fig.1&2**). The two pieces are counter to each other. The fracture had taken place in fatigue manner initiating from shear lips (**fig.4**). Fatigue had progressed up to about 10mm depth in transverse direction and remaining fracture face is crystalline in nature. (**fig.3**). As per referred letter, the CP Top Pin in service of BVZI wagon no. is given NWR – 8110980012 whereas NWR 86110980012 is mentioned on sample (**Fig. 3(a)**).

Fig.1 Photograph of broken Center Pivot Pin after joining the received broken pieces.

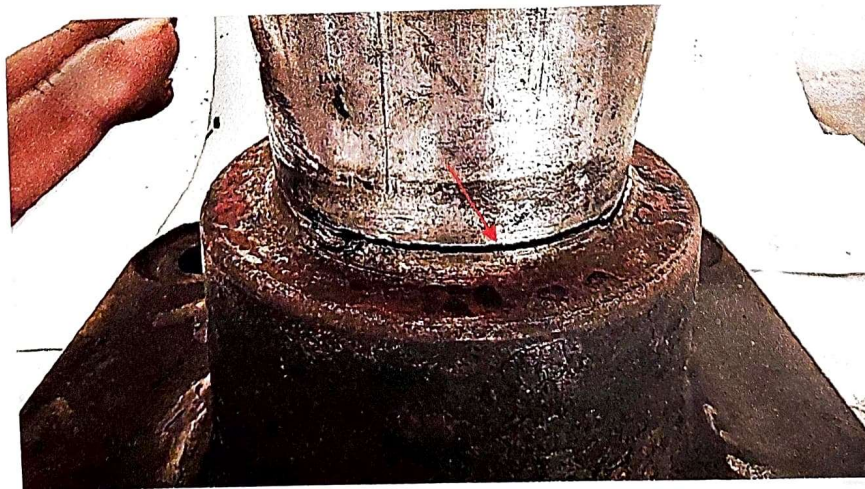
Fig.2 Close view of failed Center Pivot Pin shown in fig.1 above.

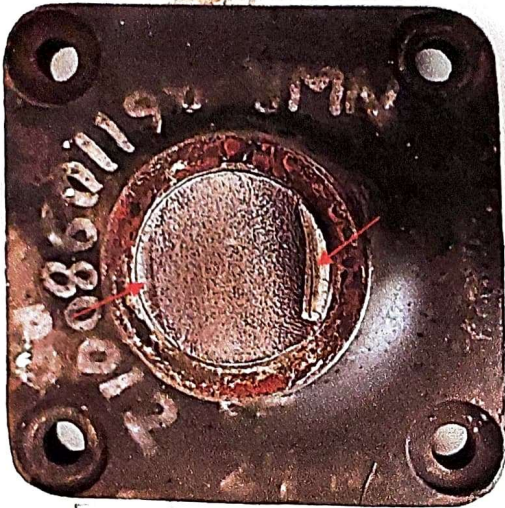
Fig. 3(a) showing the fraction face (fatigue zone) of sample no. 153/23/1.

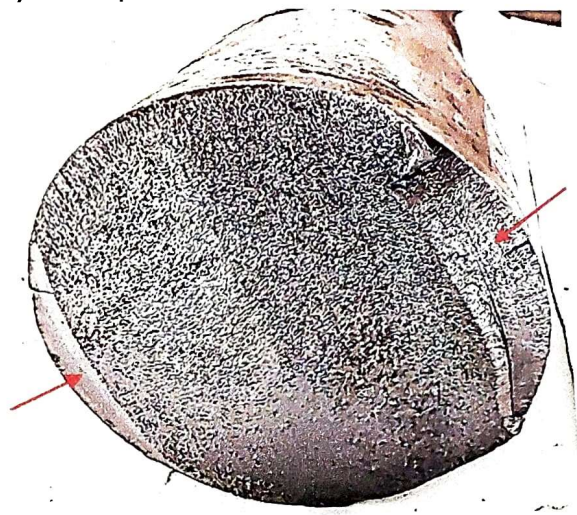
Fig. 3(b) showing fracture face (fatigue zone) of sample no. 153/23/2.

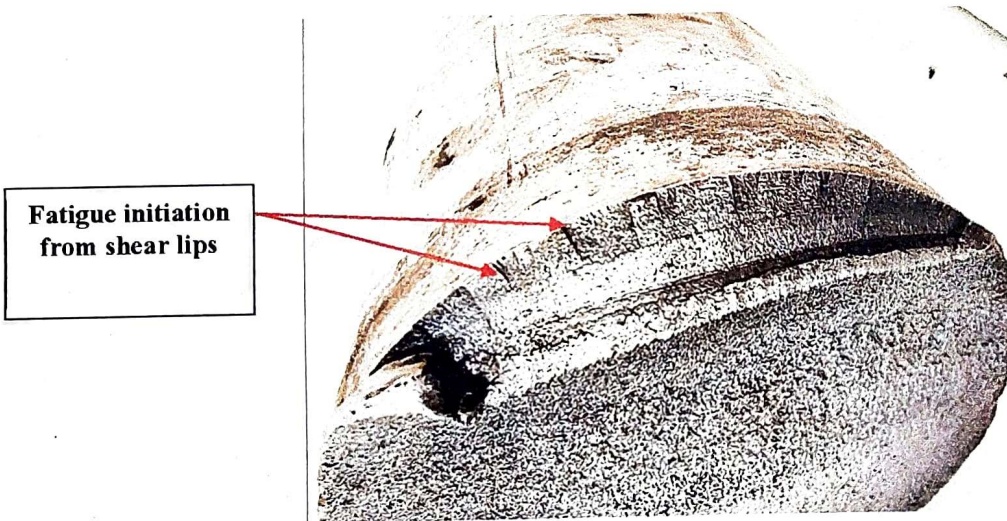
Fig. 4 Photograph of fracture face showing shear lips and subsequent fatigue initiation from the shear lips in sample no. 153/23/2.

It is evident from above that metallurgical properties of failed CP Top Pin conform to the relevant specification. Visual examination revealed that CP Top Pin had failed transversely from the transition zone. The fracture had taken place in fatigue manner initiating from shear lips. No abnormality is observed adjacent to the fracture face. The failure of CP Top Pin might have taken place due to other than metallurgical aspects.

Metallurgical properties of CP Top Pin conform to the relevant specification. The failure of CP Top Pin in fatigue mode may be attributable to other than metallurgical aspects.

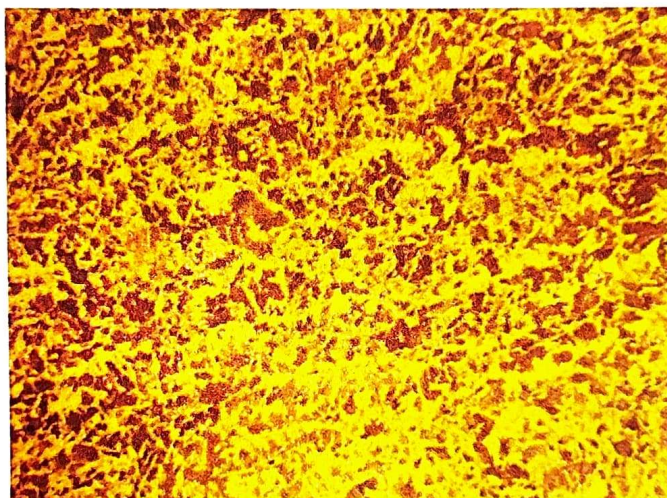
Fig.5 Photomicrograph showing normalised Ferrite-Pearlite structure.

Micro-examination revealed normalised Ferrite-Pearlite structure which is satisfactory.

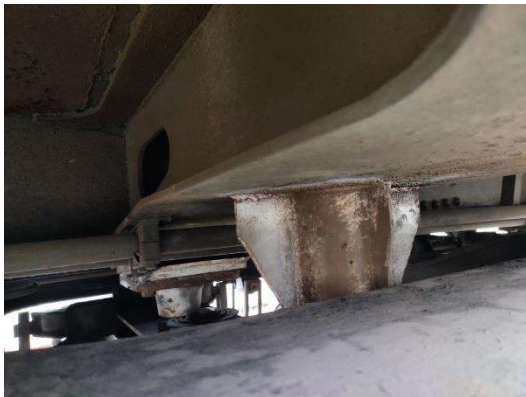
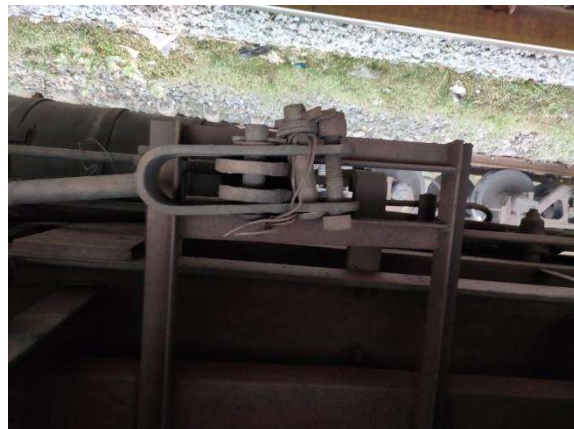
1. Brake Van No. : SER 86071102096 BVZI
2. Manufacturer and year: Jessop & Company Limited Jessop - 2011
3. Last POH: KGPW- 11.11.2022
4. Last IOH : Not done
5. Return date:11/2024
6. Condition :
 - a. Centre pivot pin broken (shear off on non-hand brake bogie side)
 - b. Side bearer welding failure.
 - c. Nonstandard pin found in hand brake lever
 - d. Hand brake pull rod secured by iron wire.
 - e. There are no symptoms found of brake binding.
 - f. The wagon was at station line and no facility was available to lift, as such CP pin and side bearers cannot be examined.

Centre Pivot Pin Broken

Hand brake fork fitted with wrong size pin

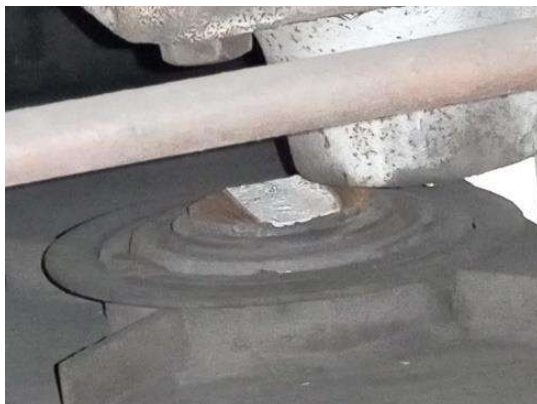
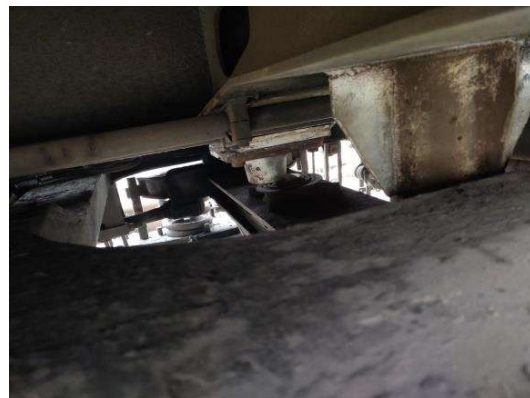
. Centre Pivot Pin Broken

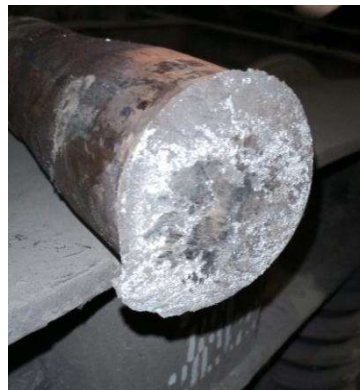
1. Brake Van No. : ER 86021002551 BVZI
2. Manufacturer and year: Jessop & Company Limited Jessop - 2010
3. Last POH: ADLW - 26.7.2022
4. Last IOH: BSL 20.9.2023.
5. Return Date: 09-2024
6. Condition : centre pivot pin broken (shear off on hand brake bogie side)
7. Auxiliary reservoir not fitted as per BVZI drawing. Bigger size AR fitted like ICF coach.
8. There are no symptoms found of brake binding.
9. The broken center pivot pin was dry not greased/lubricated.
10. Both the side bearers checked thoroughly, silent block, bronze piece including base plate also checked but nothing unusual found.

Broken Centre Pivot Pin

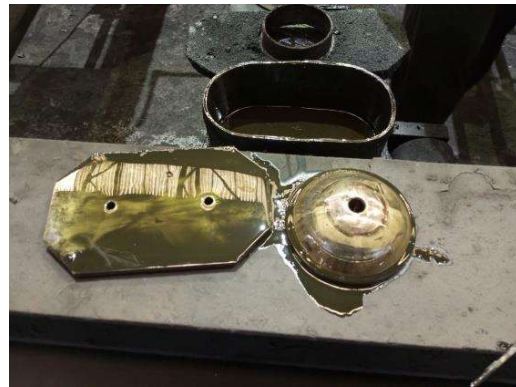
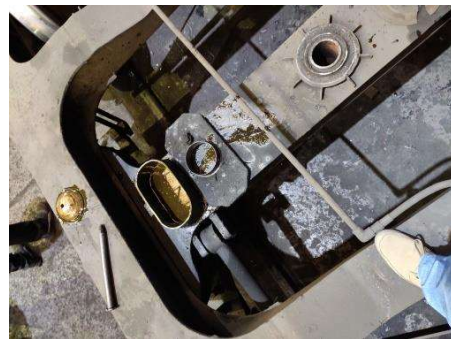
Bigger Size Auxiliary Reservoir

Side Bearer Bronze Piece With Bottom Plate
