भारत सरकार GOVERNMENT OF INDIA
रेल मंत्रालय MINISTRY OF RAILWAYS
(रेलवे बोर्ड RAILWAY BOARD)

Sub: Repair Procedures of Open Wagons.

Sub: Repair Procedures of Open wagons.

Ref : Guideline for repair of damaged BOXNHL wagon **GL/Repair/BOXNHL/2022** issued vide letter No. MW/BOXNHL dated 17.06.2022.

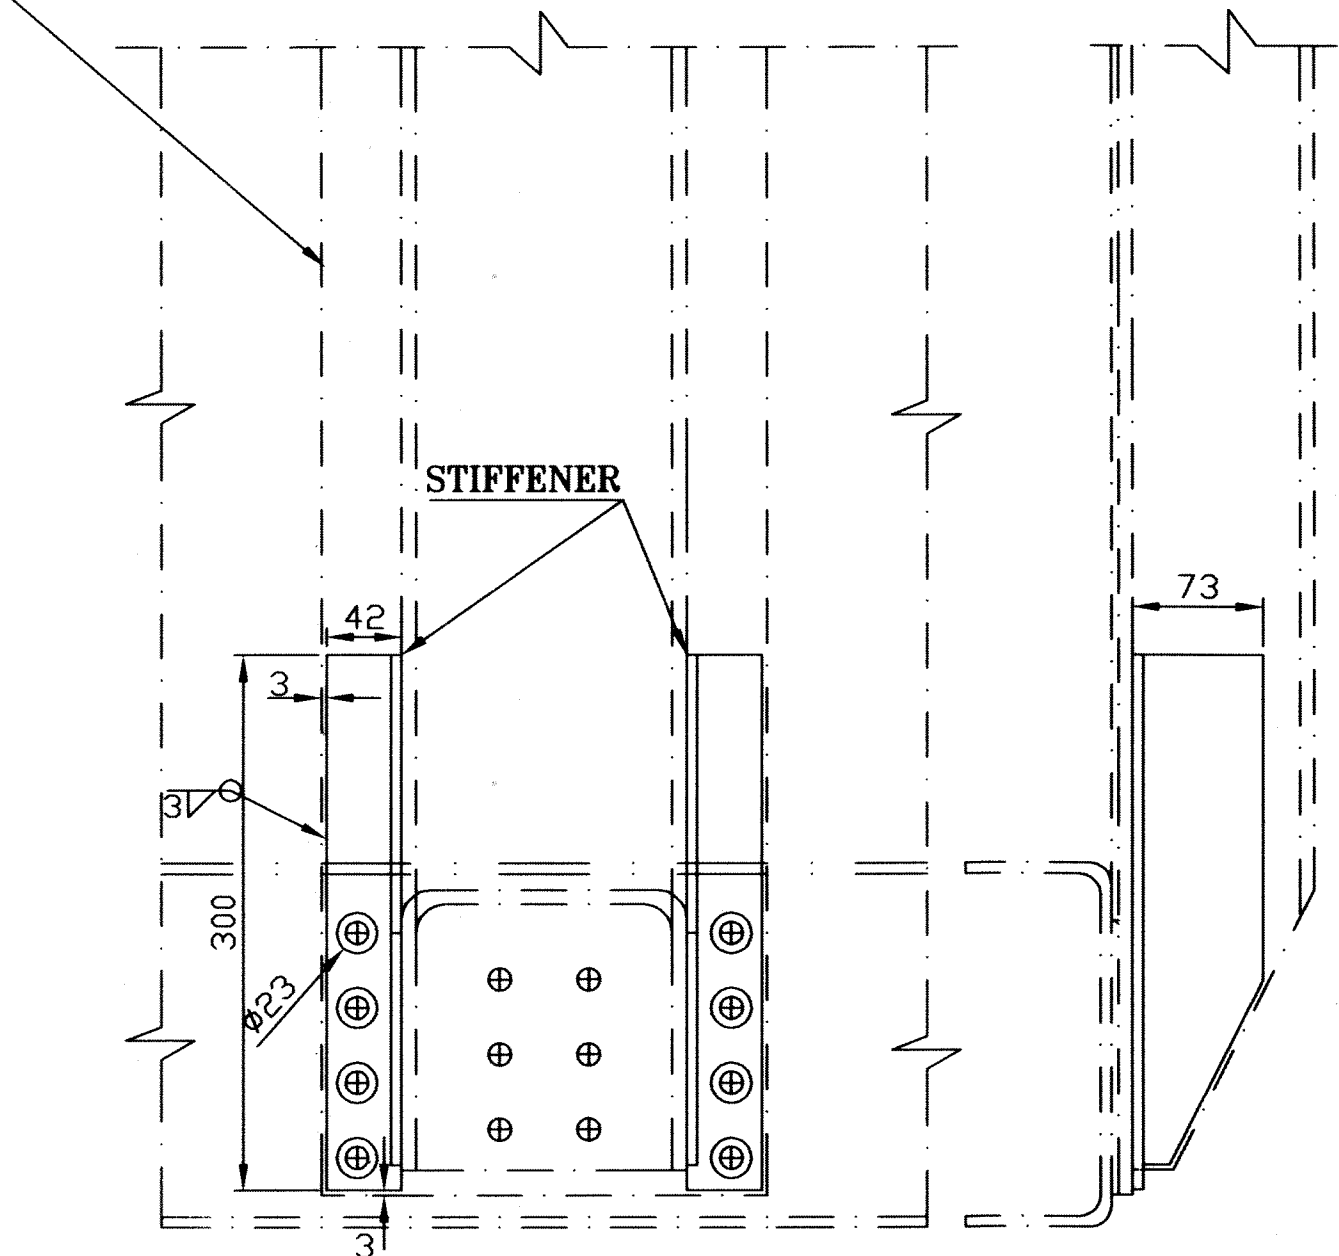
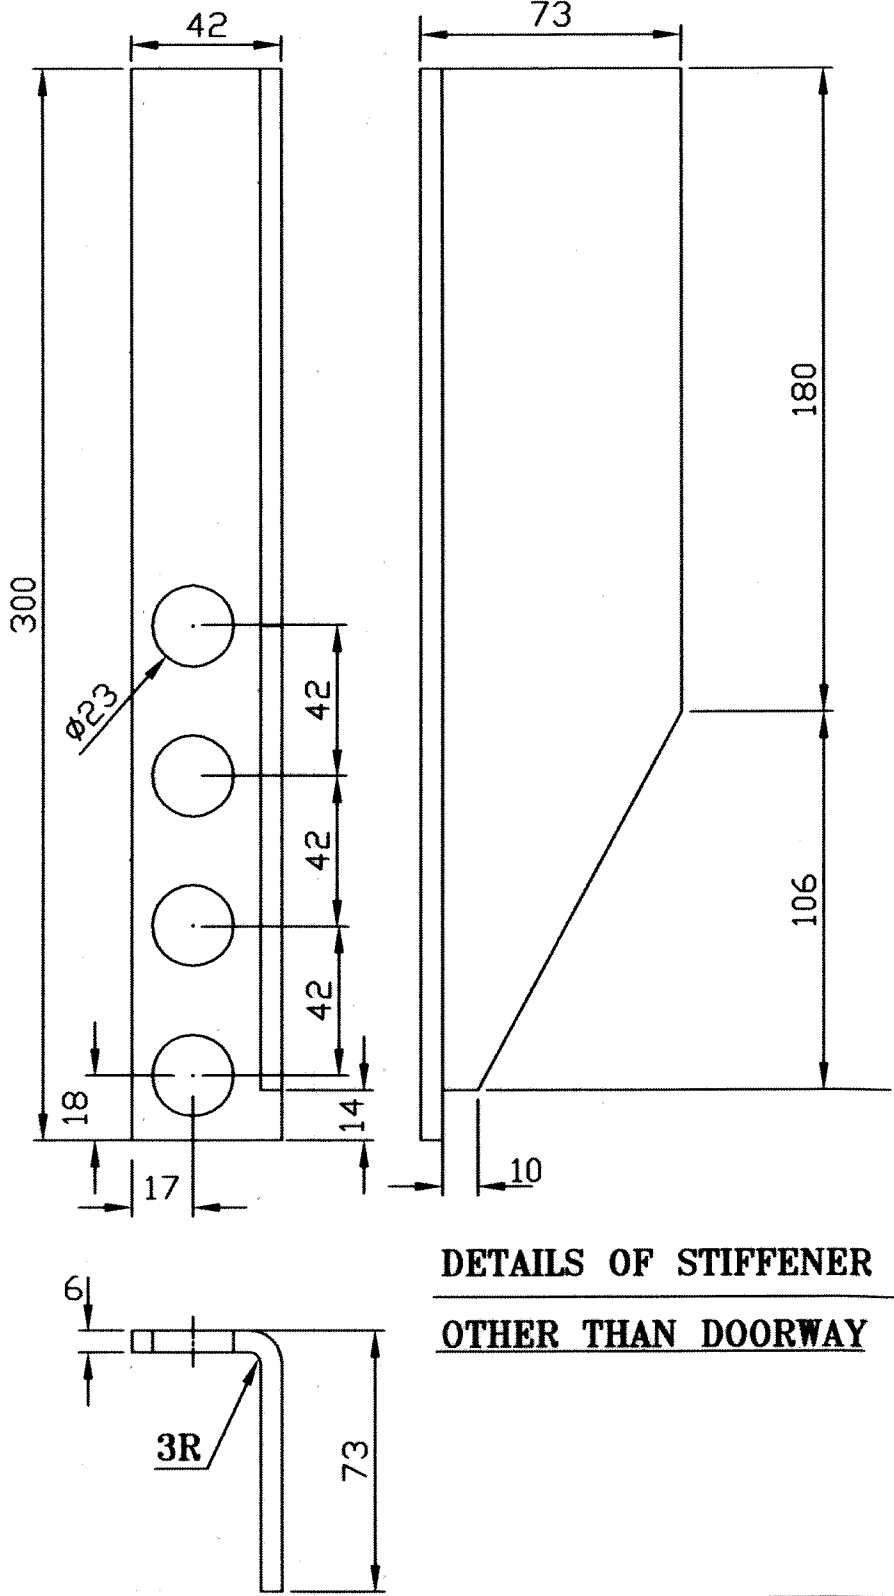
SKETCH SHOWING FITMENT OF STIFFENER WITH SIDE STANCHION

The subject issue has been studied/ inspected by RDSO. The reported failures are essentially weld joint failures of side stanchions C channel with the back plate. The failures are owing to manufacturing shortcomings – poor/no welding penetration or poor/no welding of C channel with back plate.

1. Strainghten the C-channel of side stanchion
2. Weld the C-channel of side stanchion with back plate of side stanchion after removing weld deposits of broken weld joint
3. Select the correct stiffener based on location of side stanchion
 - (i) other than doorway
 - (ii) at location of doorway
4. Weld side stanchion stiffener as per above sketch

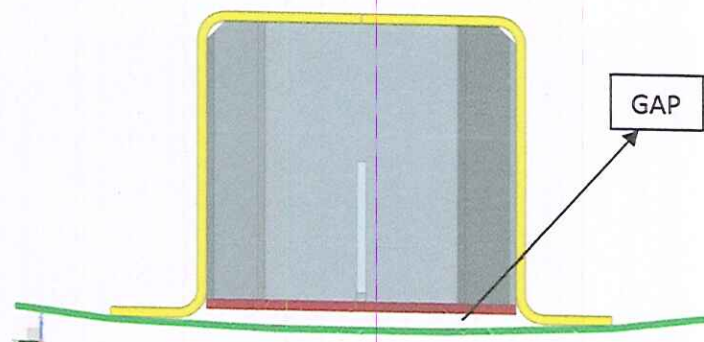
Actual Fitment of Bolster Base Plate

gusset plate should then be welded on the face of this joint. In case, the bolster bottom plate is not flush, but protrudes inwards wrt the centre sill flange, the bottom gusset plate would get welded with a gap between the gusset plate & the bolster bottom plate. With repeated hitting of the CP top, the gusset plate is liable to first plastically deform & then subsequently crack.

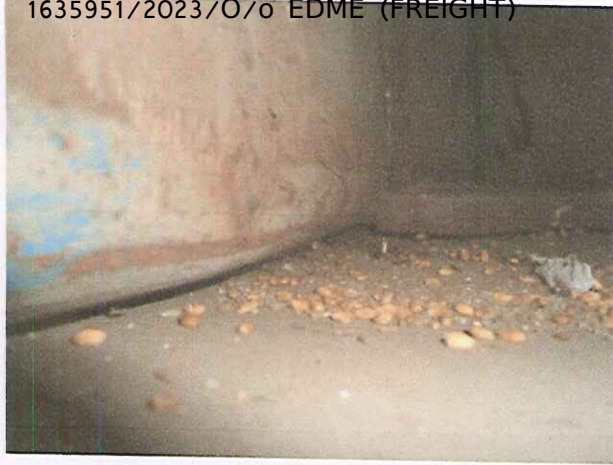
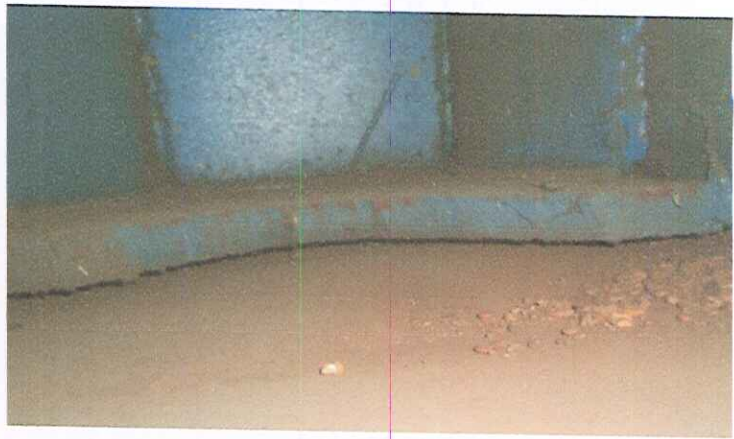
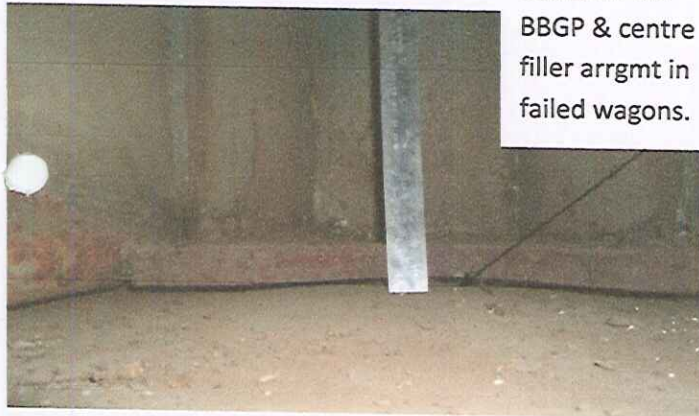
Depicted, below, is the actual arrangement, as observed in the wagons, reported with the subject failure. The arrangement, as physically inspected, in the damaged wagons, shows (1) Improper butting of the Bolster Bottom plate with the Centre sill flange AND/OR (2) A gap (when none should exist) between the bottom plate of the centre filler & the BBGP. The noticed defects are also illustrated in the below pasted photographs.

- (a) In all cases, the reported failure is of the bottom bolster gusset plate(BBGP).
- (b) The BBGP has been mostly observed to show crack near the mating area/ overlap portion with the bolster bottom

- (c) In all failure cases, a significant gap (as much as 15mm) has been observed between the BBGP & the centre filler base plate.
- (d) Gaps/ incorrect butt joint between the bolster bottom plate & the centre sill flange has been observed in all wagons with BBGP failures.

The observed gap, between the BBGP & the centre filler support arrangement, renders the centre filler support arrangement, ineffectual. It also results into a gap between the centre filler support & the BBGP, thus permitting BBGP to get deformed/ distorted in the vertical direction. The vertical forces,

Alternate-I: This is the preferred alternate. It involves removal of the existing (& cracked) BBGP. Although the alternate is expected to be time intensive, adopting it would ensure comprehensive redressal of the reported failure.

1. Carefully cut & remove the existing BBGP from the wagon. Utmost care is to be exercised to ensure that during cutting, no damage is done to the other existing structural members.

8. Apply lock bolts as per recommended practice of diagonal application & then remove the temporarily fitted mounting bolts & apply other lock bolts to fix the CP top. It be ensured that the lock bolts are of the correct dims & make. Correct swaging of the lockbolts may be also necessarily ensured.

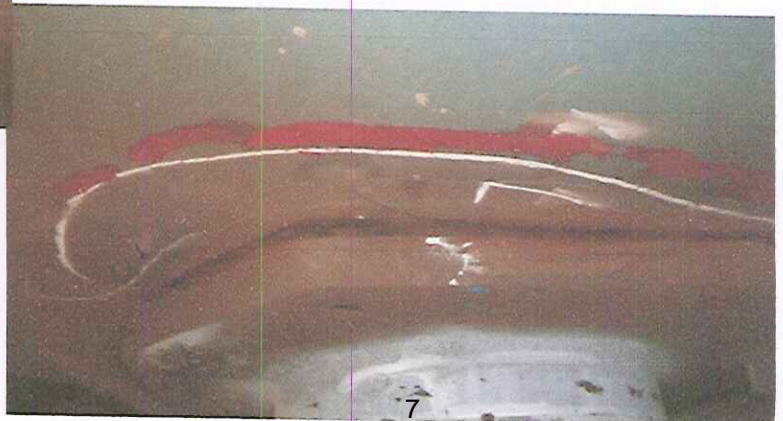
would ultimately result into a failure(crack) of the BBGP & in case the gap is not addressed, the continuous pounding of the BBGP & the lack of support from the centre filler (owing to the gap because of incorrect fabrication) could result into direct load transfer to the centre sill flange area, ultimately resulting in a longitudinal crack along the centre sill flange (in BOXNHL wagons available in JHSW, so far, no centre sill crack has been reported).

The above, cause & progression of the reported failure is corroborated by (i) the recorded gap between the BBGP & centre sill filler support (ii) cracks in all BBGP in wagons where CS cracks are reported (iii) deformation in BBGP, in all wagons with noticed gaps between the filler support & BBGP.

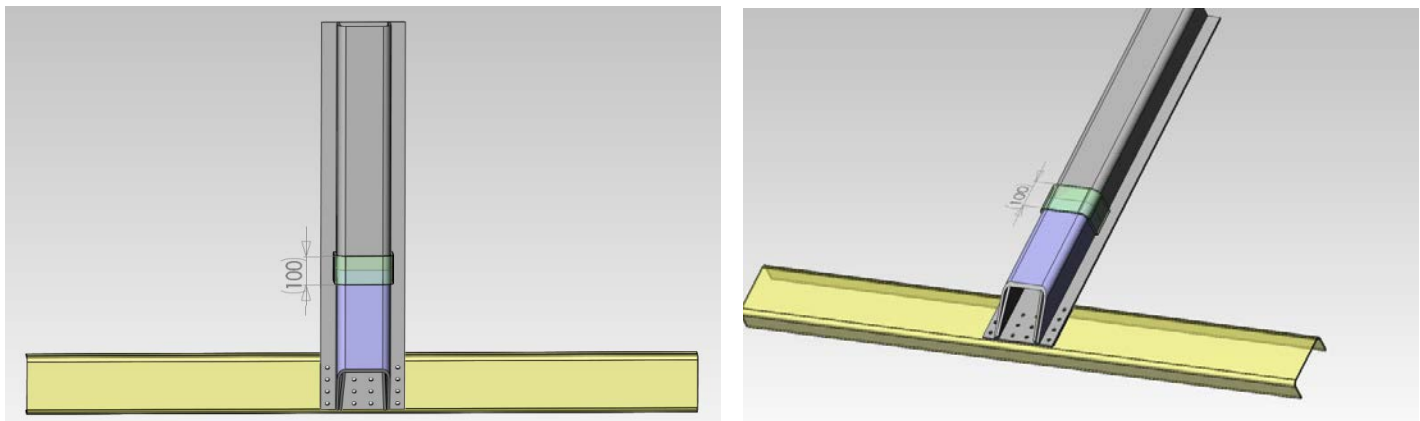
2.3. Repair of Side Stanchion when damage noticed at the joint/ near the joint of the side stanchion with Sole bar or joint of the stanchion with the top coping:

In such damages, it is recommended to repair/ replace the stanchion section of at least 450mm above the sole bar/ below the top coping, to ensure adequate strength at the bottom part which is the most critical area of the side stanchion. The repair procedure of Butt & lap joint, is recommended to be the same as above. The lockbolts, between the stanchion back plate & solebar may need to removed/ cut, for these repair. Before assembly of the new stanchion, it needs to be ensured that the back plate in the new/ replaced section of stanchion & the solebar have aligned holes of correct sizes to ensure proper lock bolting after repair of the stanchion.

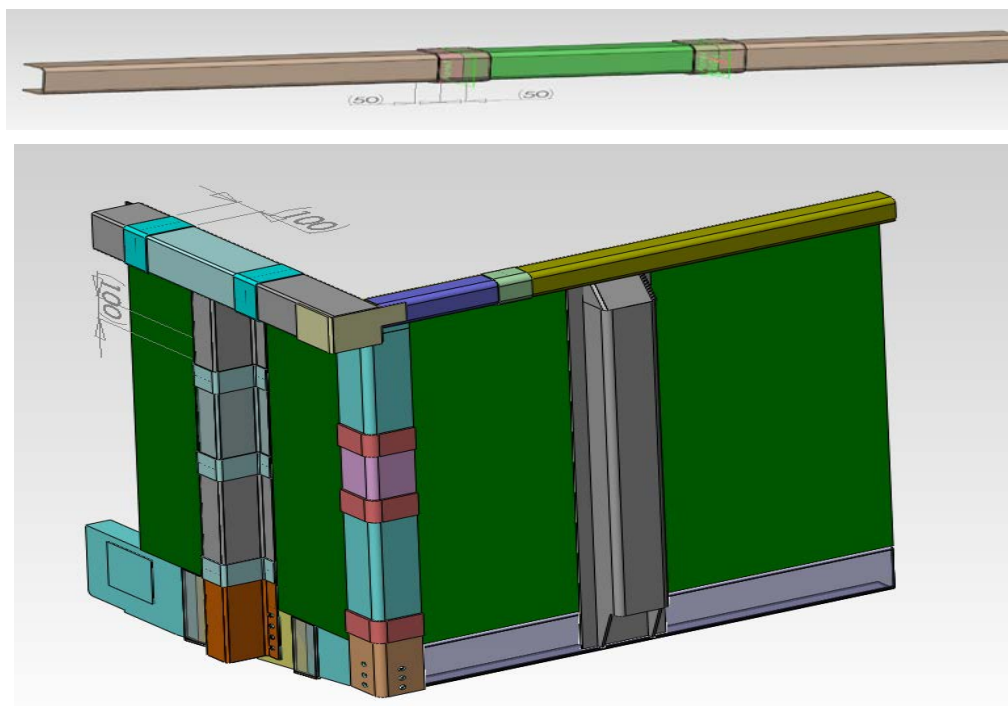
2.5. Damages to side top coping, end top coping &/ or corner joint:

The damaged portions of the Top copings are recommended to be cut and replaced with similar sections, as recommended for stanchions. The similar repair process of Butt joint, reinforced with a lap joint, as recommended for side stanchions, be followed.

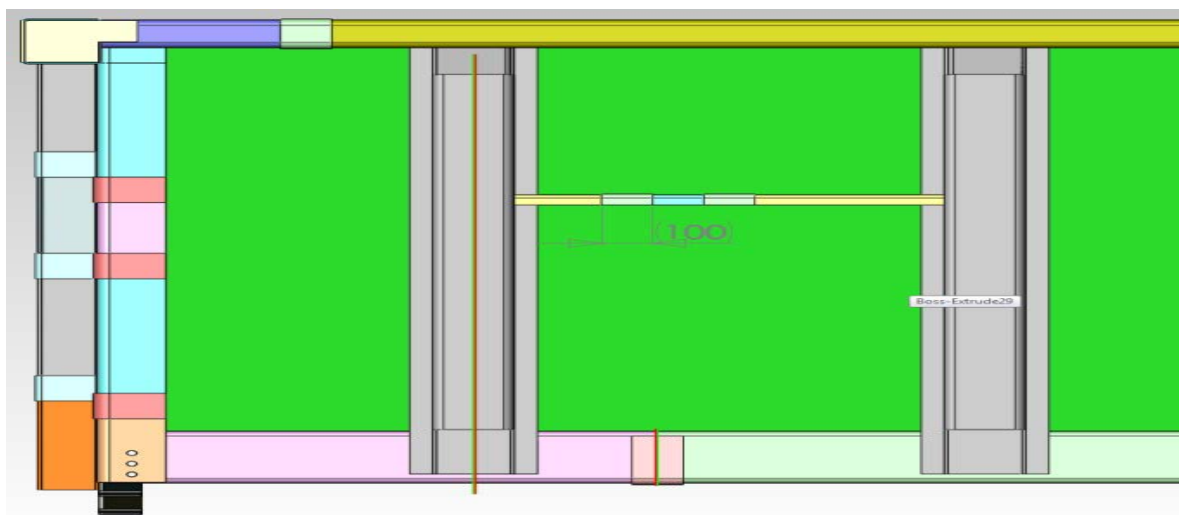
2.6. Damages to side middle copings, other structural support members & door assembly:

Side Middle Copings & other support members are recommended to be repaired, as in case of coping/ side stanchions. An illustrative sketch is indicated alongside.

Damaged components of door assembly to be replaced on condition basis. In case of bulging of door sheet, the door may need to be un-assembled & straightened using suitable fixtures/ tools. In case of heavy damage/ bulging that cannot be rectified, the full door assembly may need to be replaced. If required door to MS material as per drg. no WD-22006-S-01 can be used as replacement.

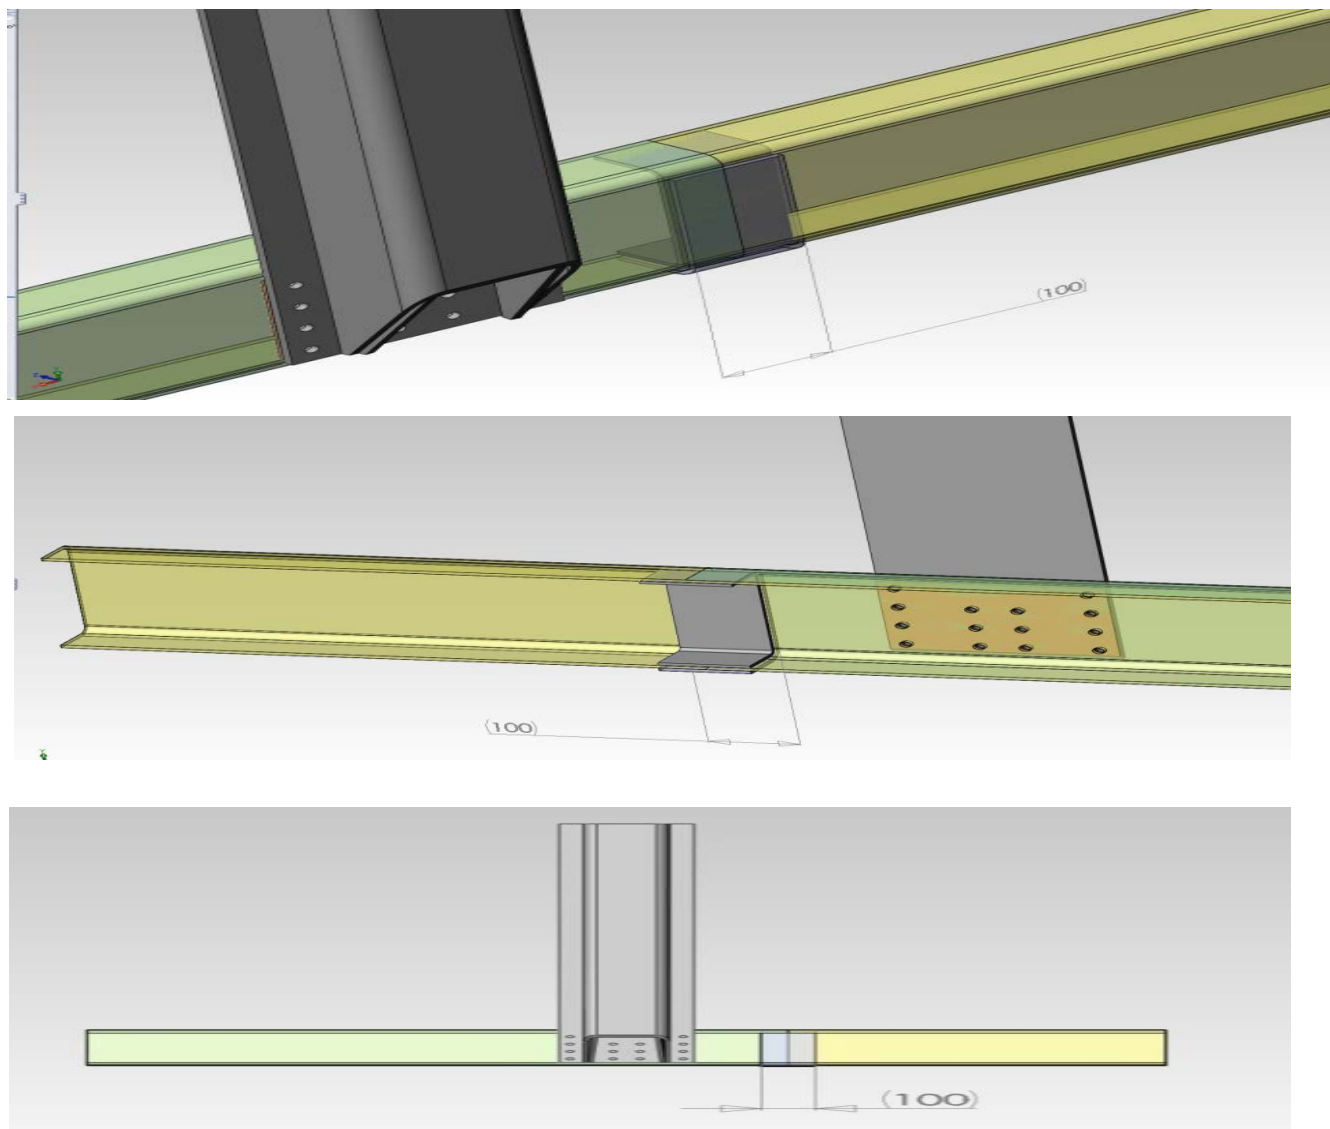
For repair of damaged portions of solebar, it is recommended that the damaged portions be cut and replaced by a repair piece of similar section & of adequate length. Apart from the butt weld, it is also recommended that an overlap joint be ensured between the but welded repair piece & the originally available sole bar.

The procedure to be followed by workshops to repair such cases is to place plate inside the solebar, to match with its profile and to drill holes to match position of holes with that of body side stanchion. If however workshops can find a alternative method to attend to such cases the same may be applied by them keeping the overall structural integrity I view.

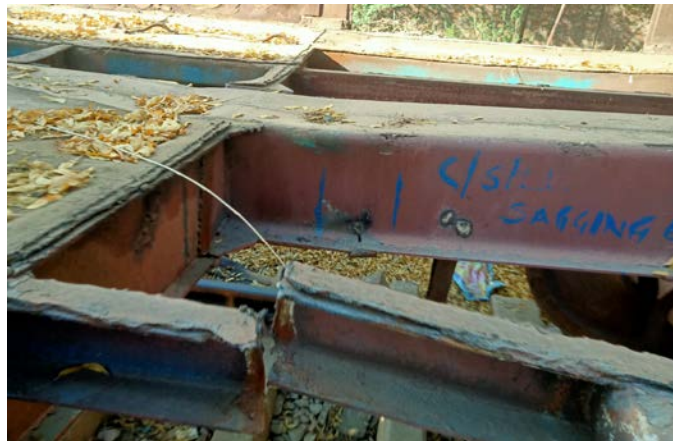
Shown below is case of centre sill having sagged.

Now to cope up with such sagging cases of centre sill, a general repair procedure has been developed for centre sill sagging repair of BOXNHL wagon and same has been issued to Kota workshop vide MW/ BOXNHL letter dated 10.03.21.

To repair the sagging of centre sill of BOXNHL wagon, the following steps are recommended:

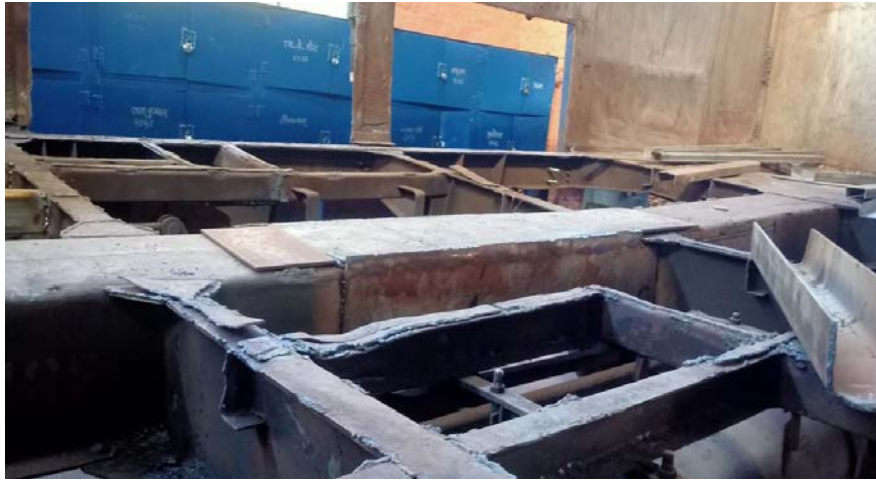
The photograph of repaired centre sill with sagging as per the repair procedure described is shown below for reference.

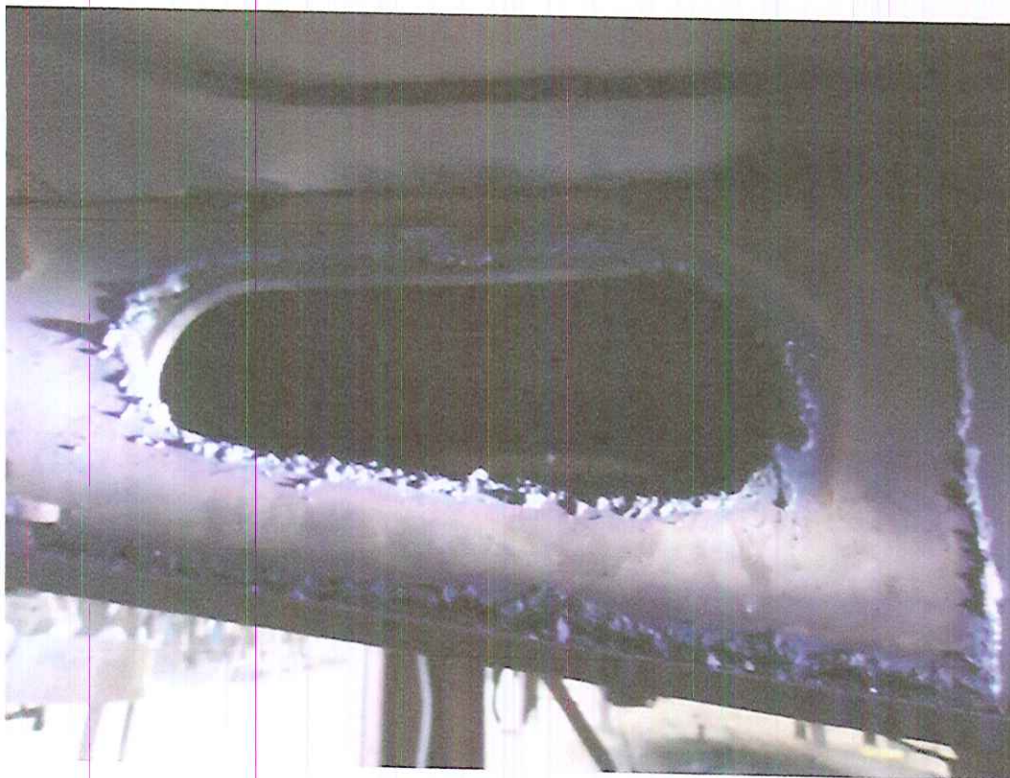
Repair similar to the above recommendation, has been initiated by JHSW by using a gas cut piece of similar material. The photo below shows repair of the same. It is evident that using such poorly cut patch plates, is bound to further worsen the failure. It is hence requested that proper care be taken to avoid stress concentration points.

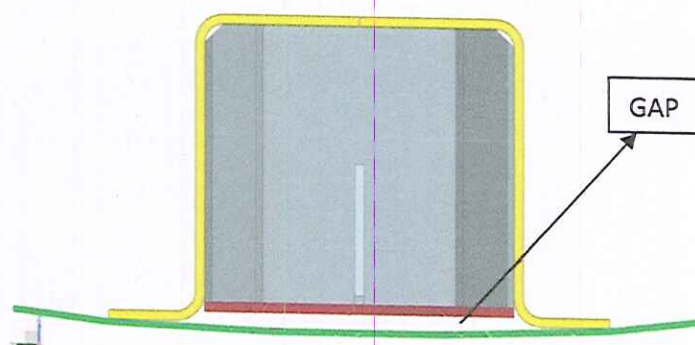
Actual Fitment of Bolster Base Plate

gusset plate should then be welded on the face of this joint. In case, the bolster bottom plate is not flush, but protrudes inwards wrt the centre sill flange, the bottom gusset plate would get welded with a gap between the gusset plate & the bolster bottom plate. With repeated hitting of the CP top, the gusset plate is liable to first plastically deform & then subsequently crack.

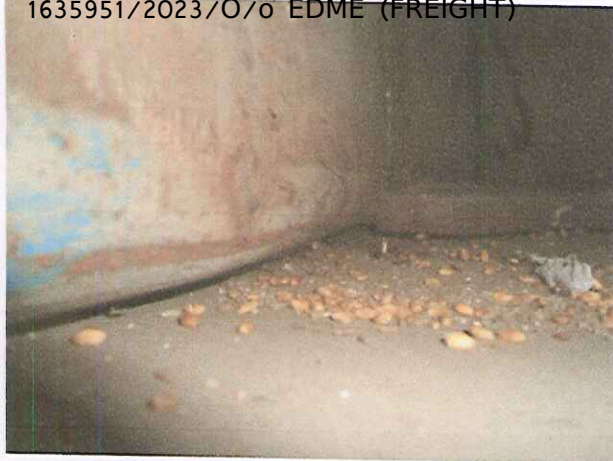
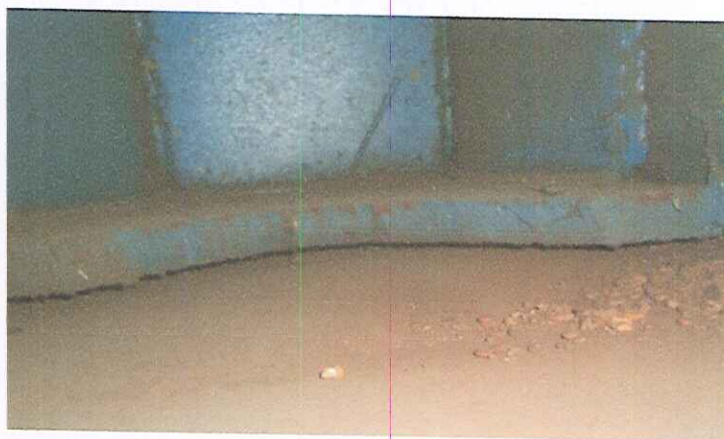
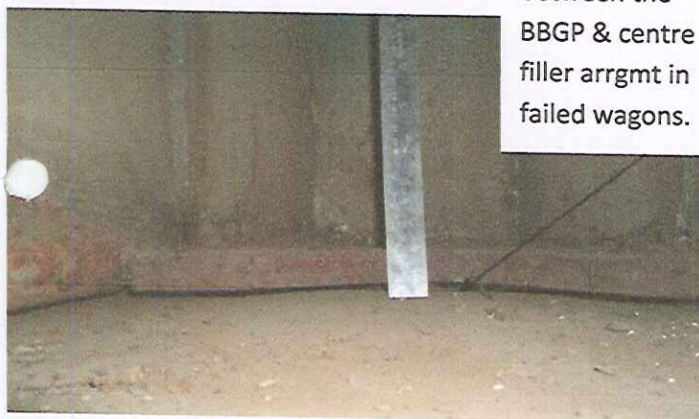
Depicted, below, is the actual arrangement, as observed in the wagons, reported with the subject failure. The arrangement, as physically inspected, in the damaged wagons, shows (1) Improper butting of the Bolster Bottom plate with the Centre sill flange AND/OR (2) A gap (when none should exist) between the bottom plate of the centre filler & the BBGP. The noticed defects are also illustrated in the below pasted photographs.

Gap inspected
between the
BBGP & centre
filler arrgmt in
failed wagons.

(a) In all cases, the reported failure is of the bottom bolster gusset plate (BBGP).

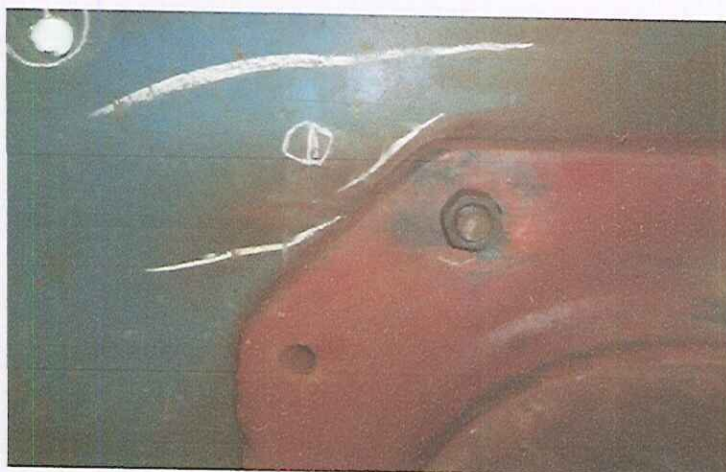
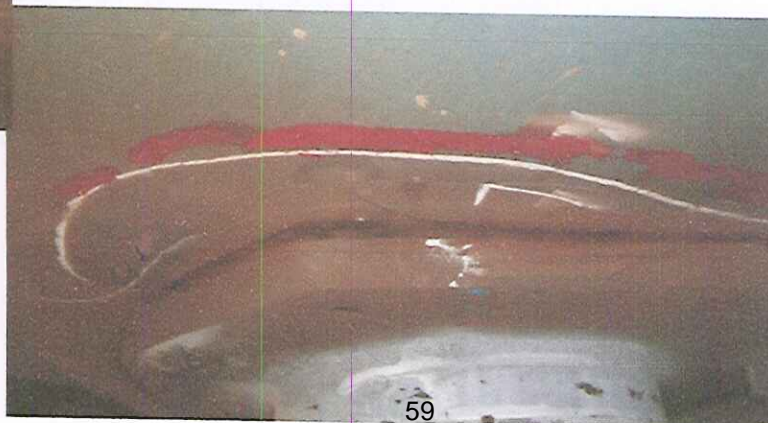
The observed gap, between the BBGP & the centre filler support arrangement, renders the centre filler support arrangement, ineffectual. It also results into a gap between the centre filler support & the BBGP, thus permitting BBGP to get deformed/ distorted in the vertical direction. The vertical forces,

from the CP, directly deform the BBGP, owing to the gap available between the two assemblies. This deformation,

would ultimately result into a failure(crack) of the BBGP & in case the gap is not addressed, the continuous pounding of the BBGP & the lack of support from the centre filler (owing to the gap because of incorrect fabrication) could result into direct load transfer to the centre sill flange area, ultimately resulting in a longitudinal crack along the centre sill flange (in BOXNHL wagons available in JHSW, so far, no centre sill crack has been reported).

The above, cause & progression of the reported failure is corroborated by (i) the recorded gap between the BBGP & centre sill filler support (ii) cracks in all BBGP in wagons where CS cracks are reported (iii) deformation in BBGP, in all wagons with noticed gaps between the filler support & BBGP.
