Sub: Strengthening of ICF bogie Frame.

Sub: Bogie Alteration Instructions for BG mainline and self-propelled ICF design coaches.

Sub: Bogie frame strengthening in connection with Bogie frame crack.

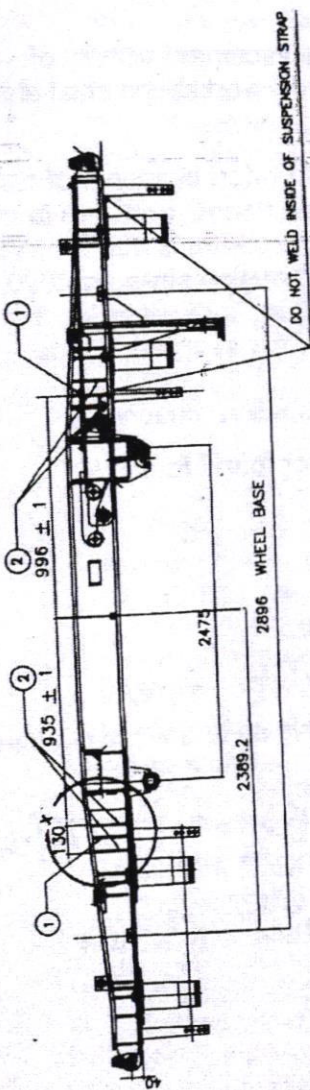
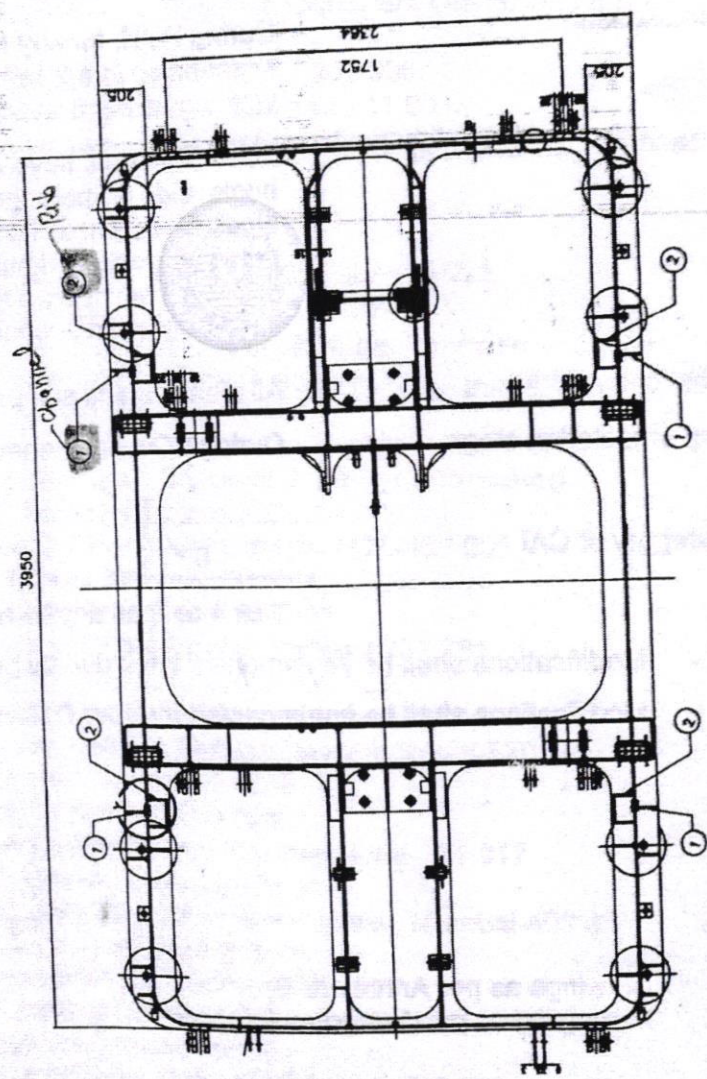
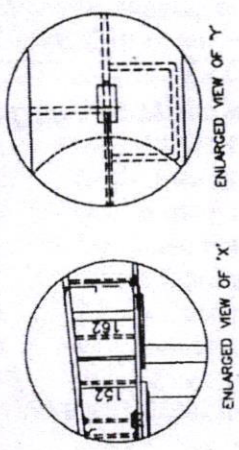
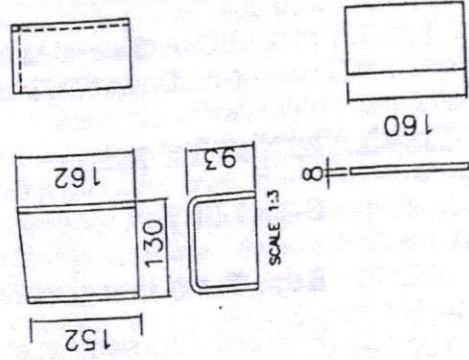
MODIFIED LOCATIONS IN BOGIE FRAME INDICATED WITH 1 & 2

1. Fatigue crack initiation from weld junction between axle guide and side frame bottom plate.
2. A wide gap (4 mm) between welded plates (guide plate and side frame bottom plate) had been found which had adversely affected the performance. These are inherent welding execution deficiency.
3. Lack of fusion was observed in the fatigue initiation region during micro examination.
4. Lack of fusion and lack of penetration were observed during the macro examination.
5. Chemical composition of guide plate was not satisfactory in terms of Carbon content which was found higher than the specified limit (0.25% against 0.22% max.).

6. The wider gap between plates may be due to shifting of plates while executing the welding, caused by loose fixture or inappropriate placement of plates before commencement of welding. Such wider gap may always lead to lack of fusion and lack of penetration with the existing welding parameters followed, which are set for closure gaps. Such wider gap will also lead to higher stress concentration at the weld joint and will aggravate easy crack initiation due to in service impacts.
7. M&C Directorate of RDSO had concluded that while executing the welding, recommended parameters may be followed to avoid cracking due to welding. The NDT techniques may also be followed to arrest welding defects.

As an additional safeguard, it is suggested that strengthening of bogie frame may be done by providing a channel from inside and a rib from outside (at the centre of inner channel) in the area of inner Axle Guide as per RDSO drawing no. CG - 17066.(copy enclosed). General welding guidelines may be followed as prescribed in RDSO CMI No. RDSO/2012/CG/CMI-02, Amendment 1 issued vide letter No. MC/CRN/REH dated 17.07.2015.

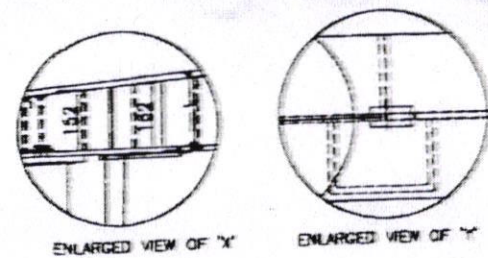
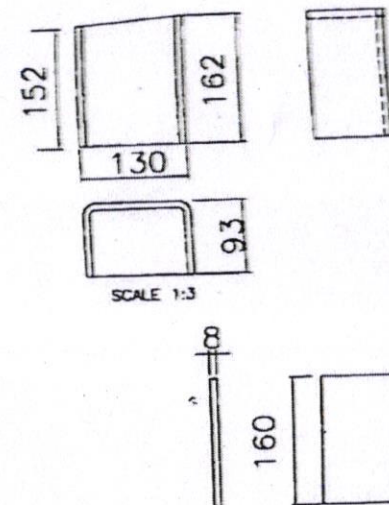
The investigations into the failed bogies had revealed deficient process during manufacture as well as poor maintenance in the field. The following deficiencies were noticed which need to be overcome to prevent the crack cases being reported:

Action may be taken to overcome the deficiencies found during investigation as listed above. Additionally it has been advised vide ref (2) and (5) that as an additional safeguard strengthening of bogie frames may be done by providing the channel from inside and a rib from outside in the area of inner Axle guide as per RDSO drawing no CG - 17066 (copy enclosed). General welding guidelines as prescribed in RDSO CMI No. RDSO/2012/CG/CMI-02 Amendment 1 may be followed.
