Sub: Pantograph entanglement in train no. 12285.
Ref: CR letter No. L.730. UOR. RB dated 26.07.2023.

Sub:- Pantograph entanglement Train no. 12285 & OHE damages at Km 762B/19, in Ballarshah - Wardha section of Nagpur division of Central Railway on 06.07.2023

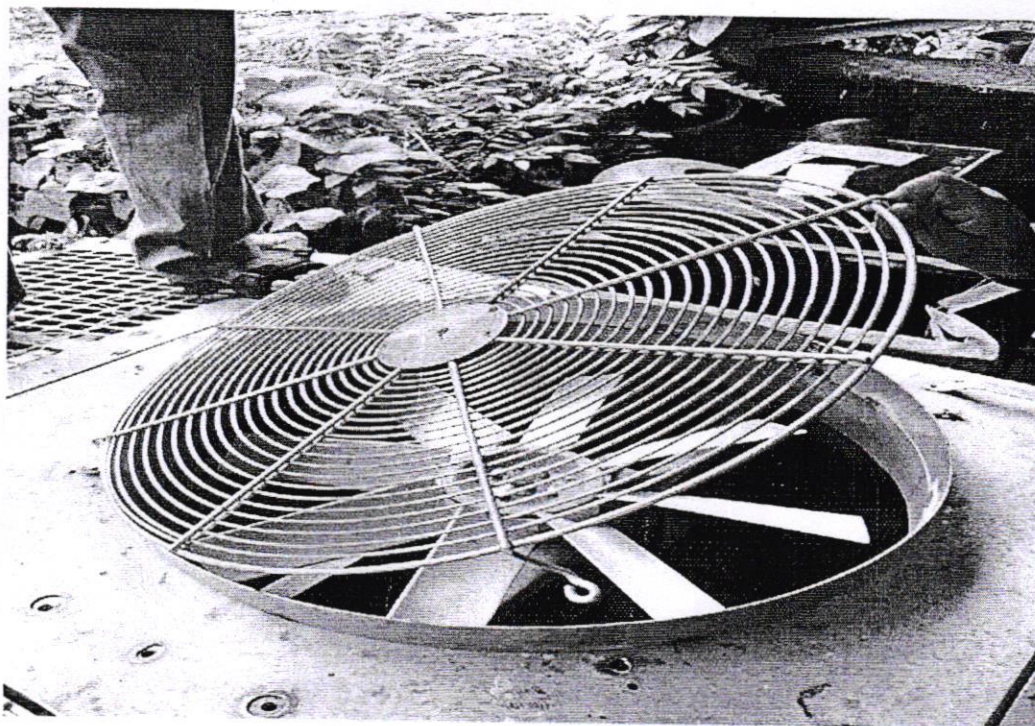
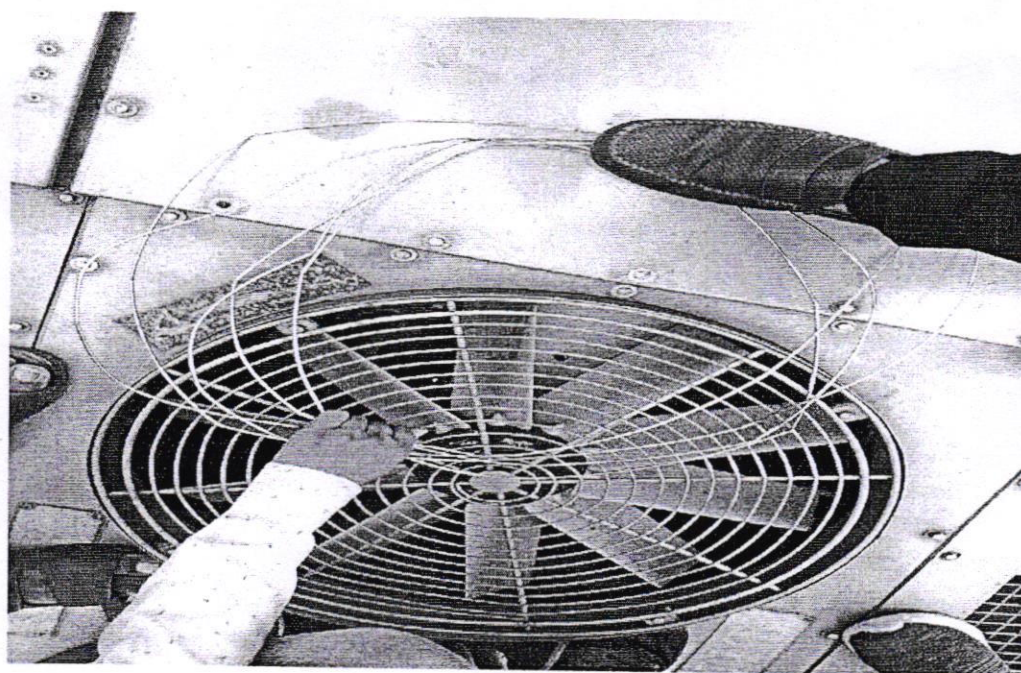
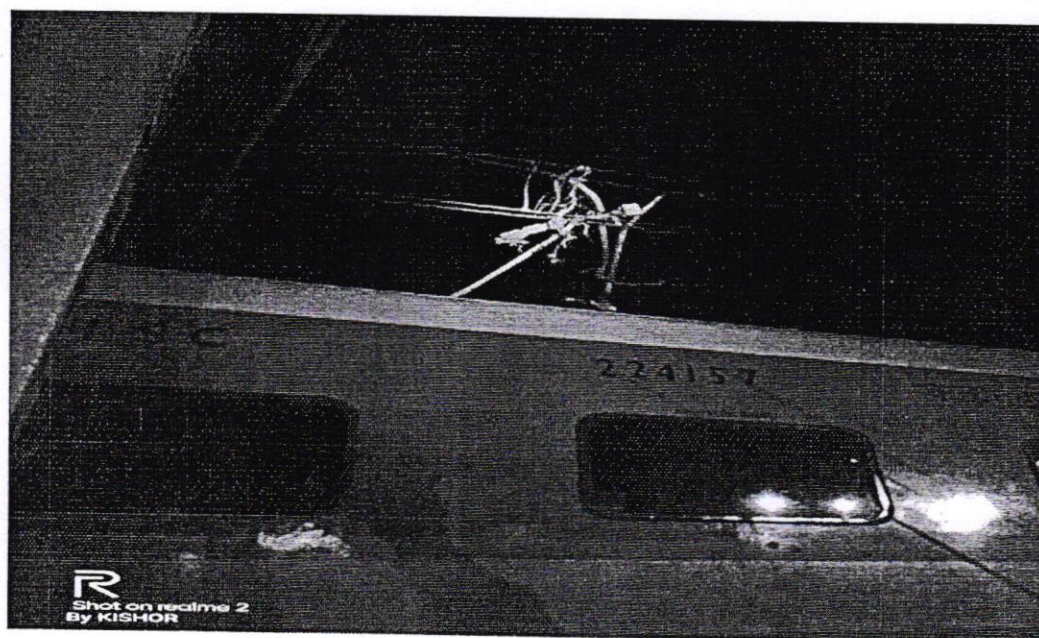
On investigation of the panto entanglement case it was found that AC coach RMPU condenser unit SS wire cage of preceding train was came out and spiral SS wire of cage got entangled with OHE. The SS wire of RMPU cage which was hanging on OHE wrapped with Pantograph and caused the panto entanglement & further damages to OHE. The SS wire found entangled on OHE was of 2.5 mm dia. & 7.5 metre length which matches with the size of RMPU unit cage spiral SS wire.

It is seen that the SS wire cage of RMPU condenser unit is fixed with RMPU body by means of 4 nos nut bolts without check nuts & due to continuous vibration during train movement the nuts may got loosen resulting to such incident. It is also noted that there is no requirement of opening of this cage during maintenance as for any RMPU attention the complete top cover is opened. The photographs of RMPU condenser unit wire cage & SS wire entangled with OHE are enclosed.

In view of the above, it is suggested to advise RDSO for issuing suitable modification for proper fixing arrangement of RMPU condenser cage on RMPU body preferably to be welded with RMPU body cover. For existing RMPU in service the tag welding may be done in addition to fixing by 4 Nos. bolts, to avoid such failures in future.
