Sub: Review of Outcome of Third Party Audit of Railway Bridge/ROBs/FOBs

Sub: Technical Report on repeated failure of vertical in 91.5M K Type truss of Bridge no-57 (Down) in Kharagpur Division of S. E. Rly.

REPORT ON THE CRACKS & DEFECTS IN DIFFERENT MEMBERS OF OPEN WEB THROUGH TYPE K - SHAPE GIRDER OF BRIDGE NO. 57 (7X300'0''G+4X100'0''G) AT KM: BETWEEN KOLAGHAT (KIG) & DEULTI (DTE) STATIONS OF KGP DIVISION

**TECHNICAL REPORT ON FAILURE OF
BRIDGE NO. 57 OF S.E. RAILWAY**

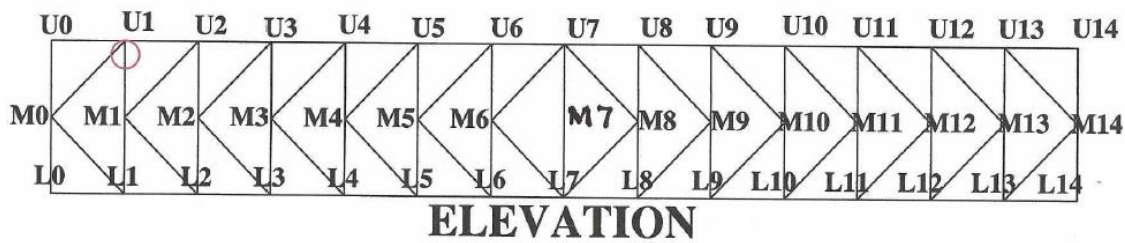
2.1 SER vide letter No. BR/CBE Cell/ dated 21.05.2014 reported structural distress in the Bridge No 57 DN. Cracks were noticed on Second Vertical U1M1(Upper) near U1 of span no. 5 (91.4m span) by BRI staff on 17.05.2024. A gap of approximately 65mm was reported at the location of crack in U1M1.

Fig.1: Full crack near U1 Node in the line of the last rivet (from Top) in Vertical & Gusset Connection.
