भारत सरकार GOVERNMENT OF INDIA
रेल मंत्रालय MINISTRY OF RAILWAYS
(रेलवे बोर्ड RAILWAY BOARD)

Sub: Repair Procedures of Open Wagons.

Sub: Repair Procedures of Open wagons.

Ref : Guideline for repair of damaged BOXNHL wagon **GL/Repair/BOXNHL/2022** issued vide letter No. MW/BOXNHL dated 17.06.2022.

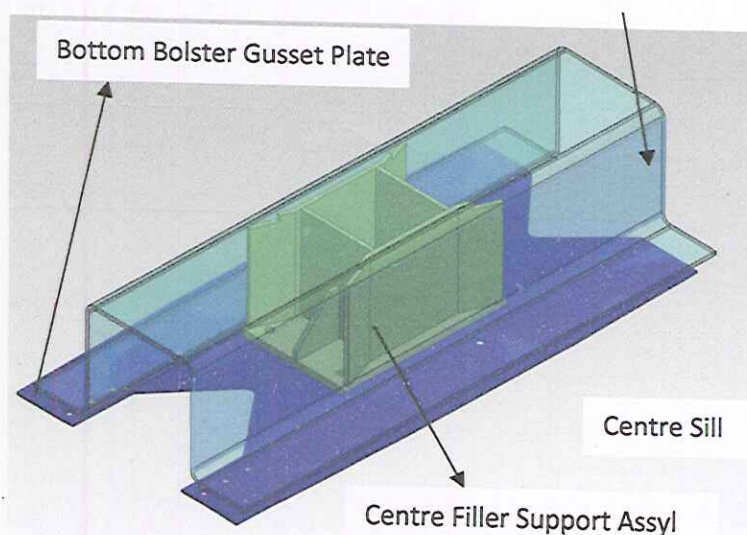
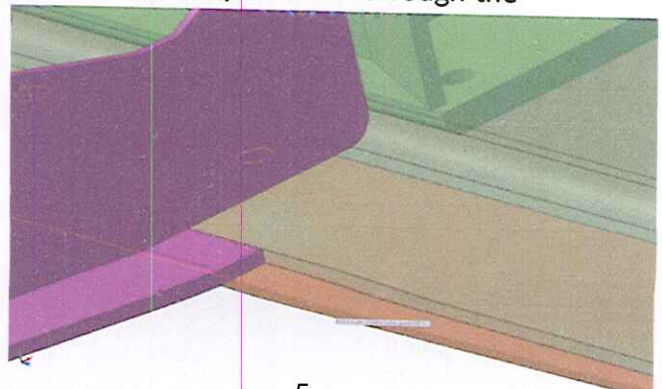
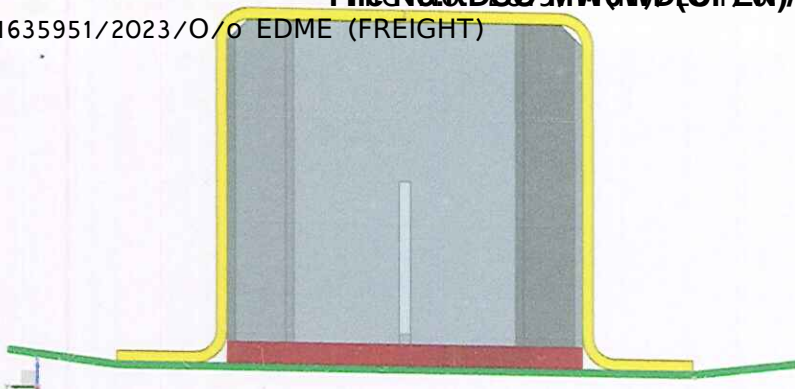
The reported failures pertain to the centre-pivot area of the BOXNHL wagon. The details of the same are enumerated in RDSO drg Nos. WD-05086-S-4 Alt 6, WD-05086-S-14 Alt 10, WD-05086-S-15 Alt 8. Depicted alongside is a modelled view of the centre pivot arrangement & the assembly therein.

As is evident therein, the Centre sill is provided with a centre filler support arrangement, to enable load distribution/ transmission of the vertical forces from

the CP Top assembly. The fabricated assembly of the centre sill-filler support arrangement- bottom bolster gusset plate, provides for the structure that distributes, the vertical force experienced through the

CP top & bottom assembly. The correct fabrication of the centre sill-filler support arrangement- bottom bolster gusset plate is hence an imperative requirement.

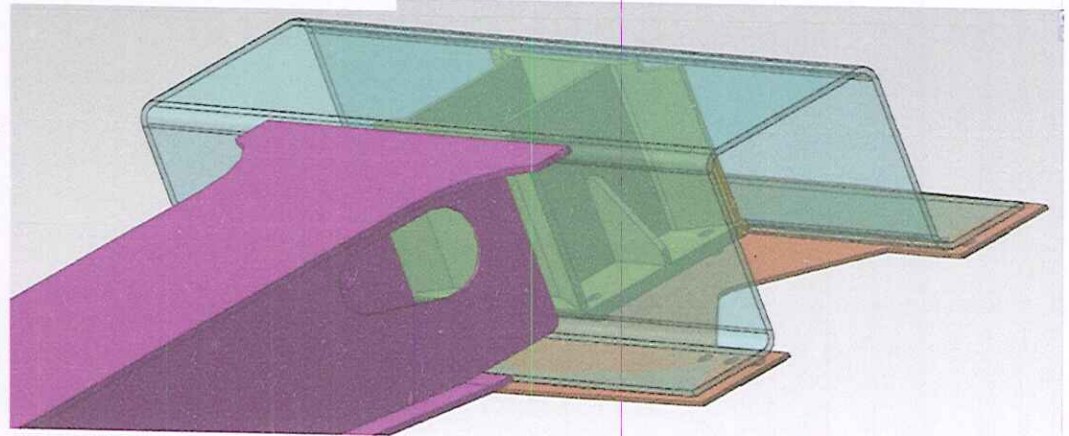
Further, as per the arrangement

shown in the drg, the bolster bottom plate should be butted flush with the centre sill flange. The bottom

gusset plate should then be welded on the face of this joint. In case, the bolster bottom plate is not flush, but protrudes inwards wrt the centre sill flange, the bottom gusset plate would get welded with a gap between the gusset plate & the bolster bottom plate. With repeated hitting of the CP top, the gusset plate is liable to first plastically deform & then subsequently crack.

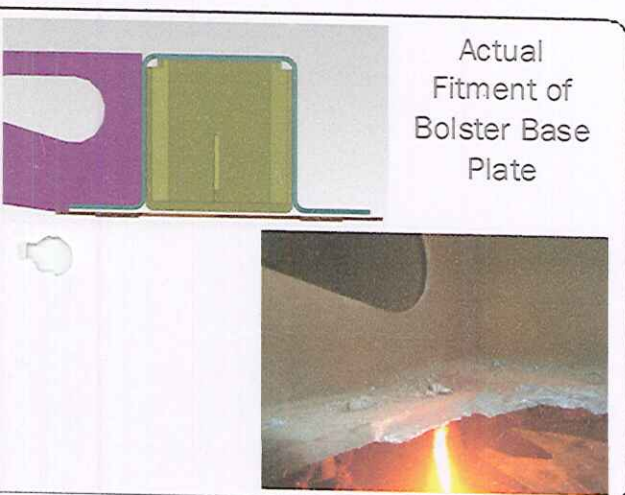
Actual Fitment of Bolster Base Plate

Depicted, below, is the actual arrangement, as observed in the wagons, reported with the subject failure. The arrangement, as physically inspected, in the damaged wagons, shows (1) Improper butting of the Bolster Bottom plate with the Centre sill flange AND/OR (2) A gap (when none should exist) between the bottom plate of the centre filler & the BBGP. The noticed defects are also illustrated in the below pasted photographs.

- (a) In all cases, the reported failure is of the bottom bolster gusset plate(BBGP).
- (b) The BBGP has been mostly observed to show crack near the mating area/ overlap portion with the bolster bottom

- (c) In all failure cases, a significant gap (as much as 15mm) has been observed between the BBGP & the centre filler base plate.
- (d) Gaps/ incorrect butt joint between the bolster bottom plate & the centre sill flange has been observed in all wagons with BBGP failures.

The observed gap, between the BBGP & the centre filler support arrangement, renders the centre filler support arrangement, ineffectual. It also results into a gap between the centre filler support & the BBGP, thus permitting BBGP to get deformed/ distorted in the vertical direction. The vertical forces,

would ultimately result into a failure(crack) of the BBGP & in case the gap is not addressed, the continuous pounding of the BBGP & the lack of support from the centre filler (owing to the gap because of incorrect fabrication) could result into direct load transfer to the centre sill flange area, ultimately resulting in a longitudinal crack along the centre sill flange (in BOXNHL wagons available in JHSW, so far, no centre sill crack has been reported).

The above, cause & progression of the reported failure is corroborated by (i) the recorded gap between the BBGP & centre sill filler support (ii) cracks in all BBGP in wagons where CS cracks are reported (iii) deformation in BBGP, in all wagons with noticed gaps between the filler support & BBGP.

Alternate-I: This is the preferred alternate. It involves removal of the existing (& cracked) BBGP. Although the alternate is expected to be time intensive, adopting it would ensure comprehensive redressal of the reported failure.

1. Carefully cut & remove the existing BBGP from the wagon. Utmost care is to be exercised to ensure that during cutting, no damage is done to the other existing structural members.

8. Apply lock bolts as per recommended practice of diagonal application & then remove the temporarily fitted mounting bolts & apply other lock bolts to fix the CP top. It be ensured that the lock bolts are of the correct dims & make. Correct swaging of the lockbolts may be also necessarily ensured.

Alternate-II: This is the less-preferred alternate & should be adopted only if the prerequisite of Alternate-I, i.e. removal of the existing BBGP is considered impractical/ not feasible. This alternate involves in-situ repair of the broken BBGP.

2. The portion of crack in the BBGP, be exposed & opened-up using gouging. Care should be taken to avoid consequent damage to other components or of further damaging the BBGP.

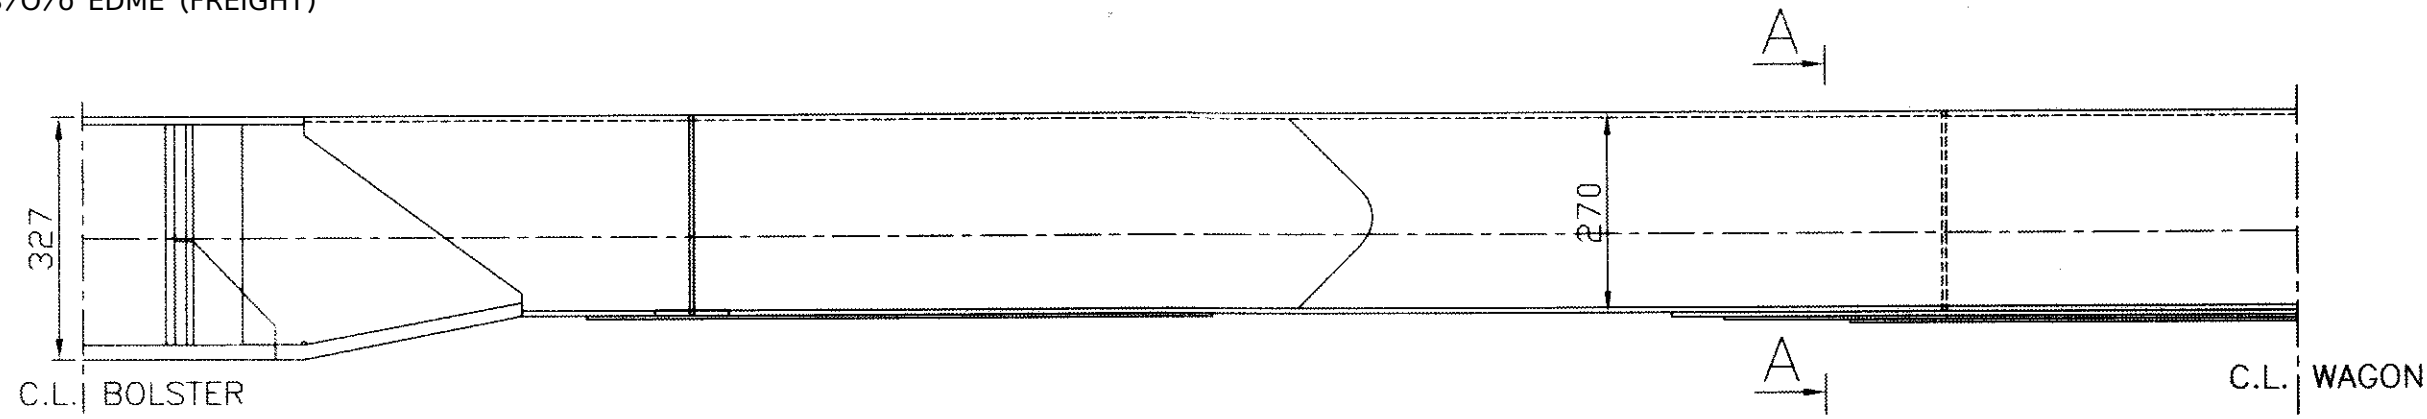
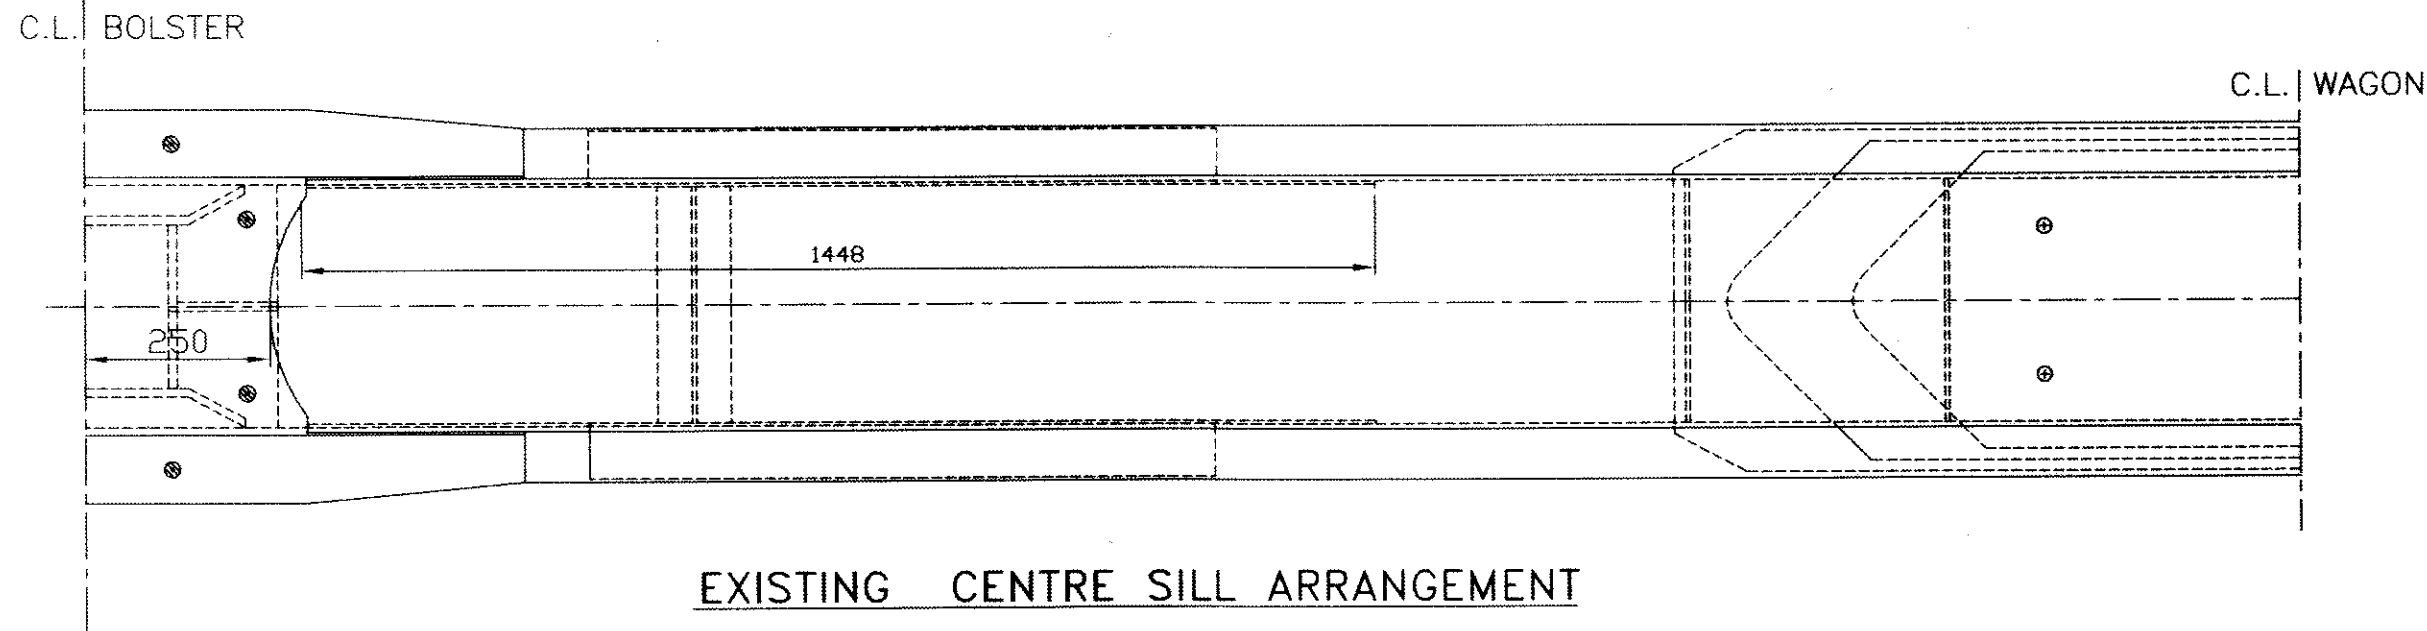
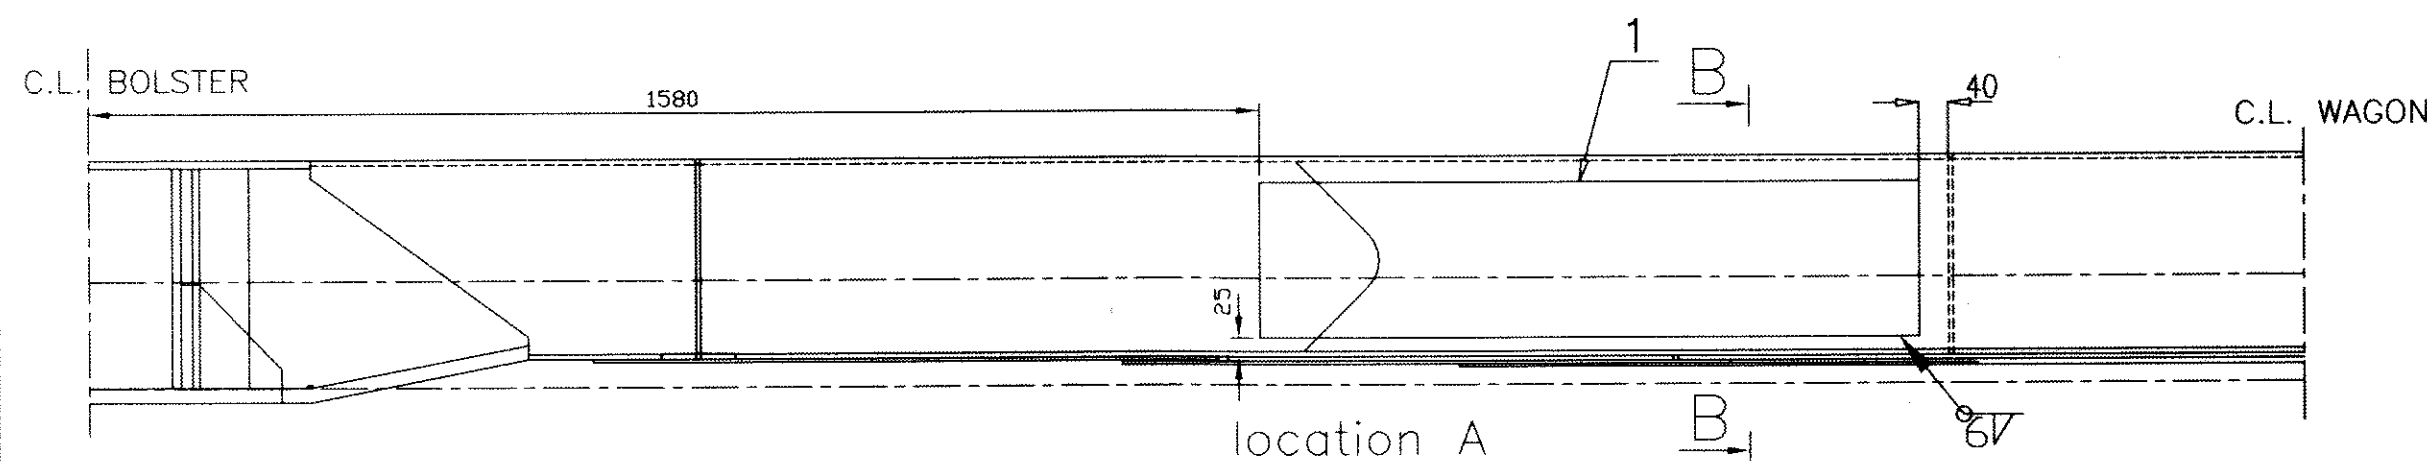
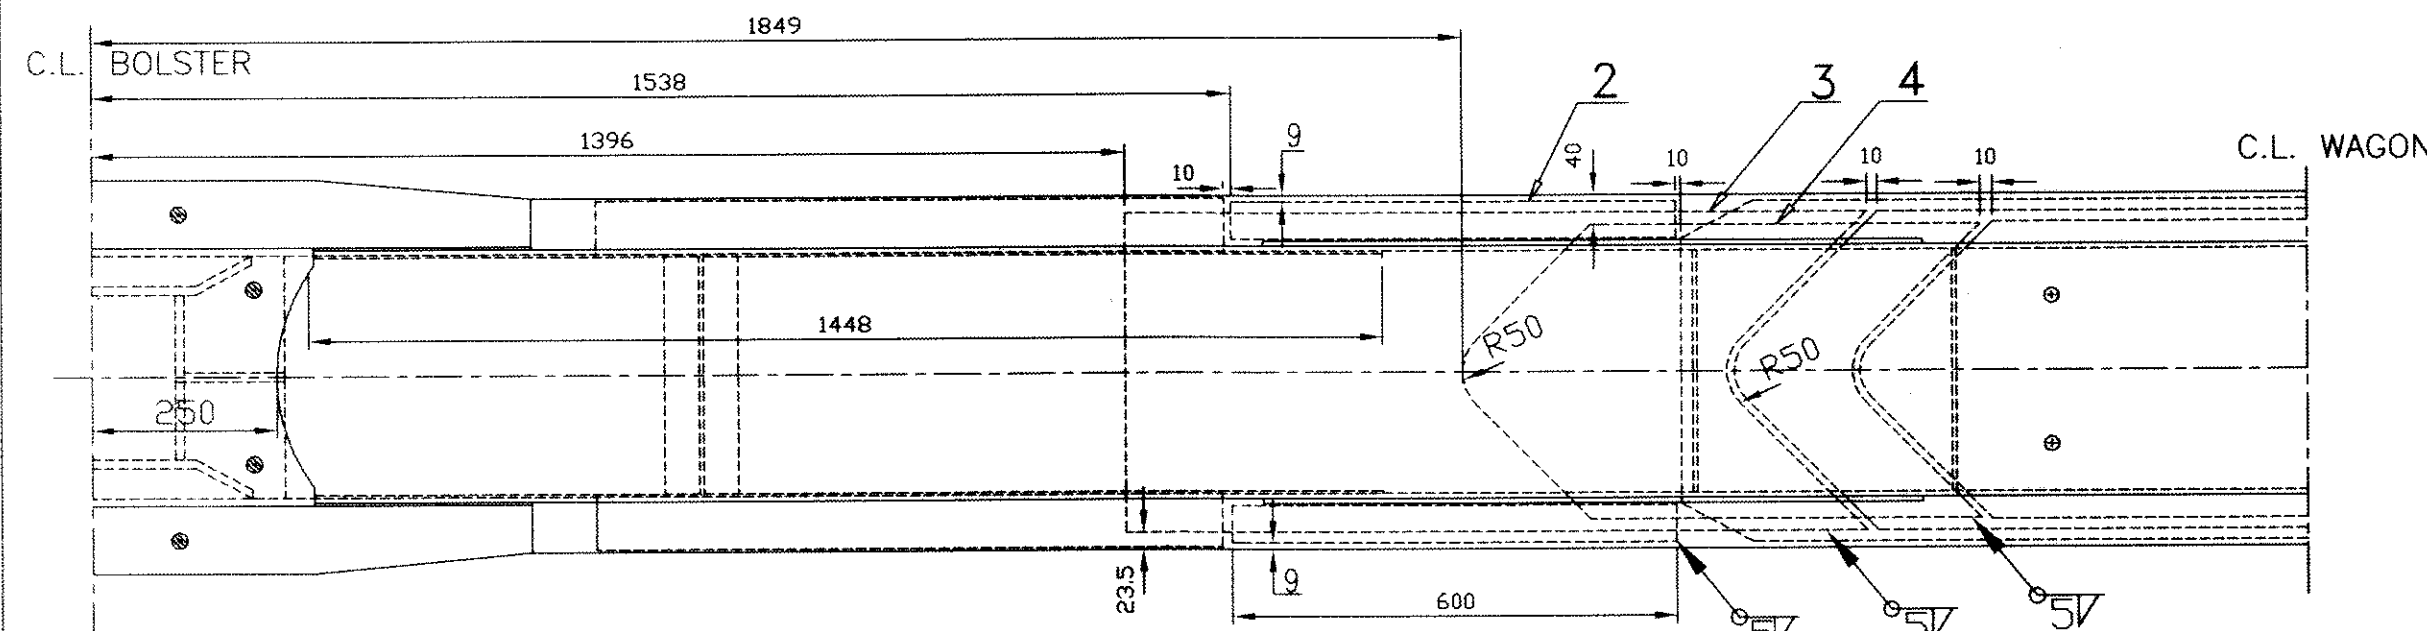
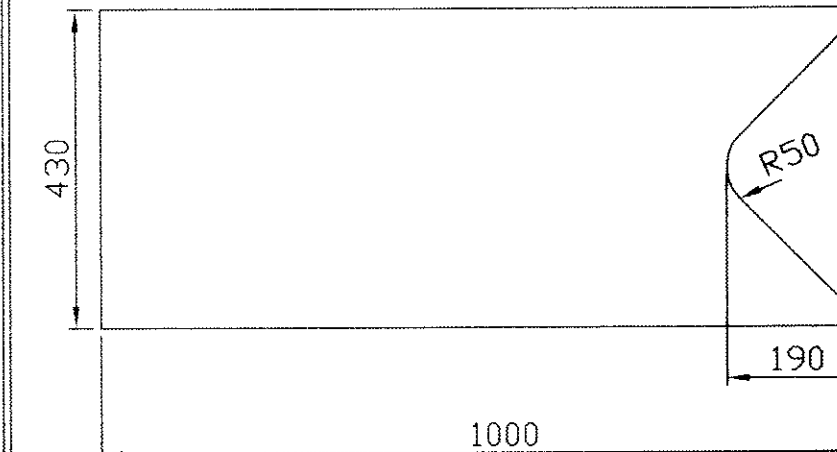
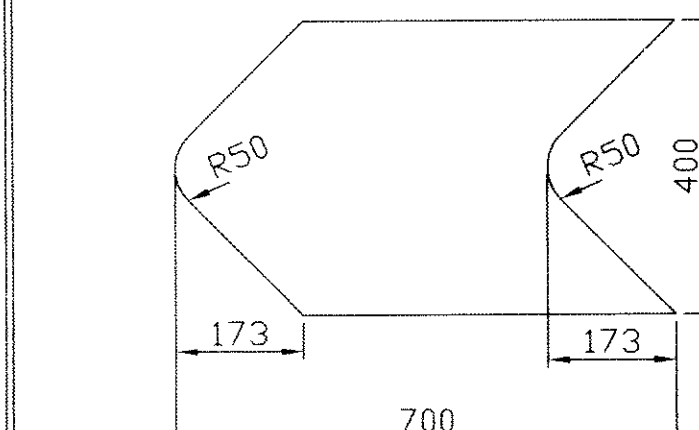
PROCEDURE FOR REPAIRING CENTRE SILL BETWEEN BOLSTERS:-

1. FOR REPAIR OF CRACKS IN THREE PIECE CENTRE SILL BETWEEN BOLSTERS FOLLOWING REPAIR PROCEDURE SHALL BE ADOPTED:
2. MAXIMUM OCCURENCERS OF CRACK HAVE BEEN REPORTED AT LOCATION A.

6. CARE SHOULD BE TAKEN FOR GOOD QUALITY OF WORKMANSHIP.
7. ALL CENTRESILL REPAIRED WAGON SHOULD BE MARKED WITH REMARK "CENTRESILL REPAIRED" AT SIDE WALL ON BOTH SIDE WITH LETTER SIZE OF 175mm.

8. ALL THESE WAGONS SHOULD BE CHECKED AT EVERY EXAMINATION POINT & FITNESS REPORT TO BE SEND TO RDSD DURING ROH & POH.

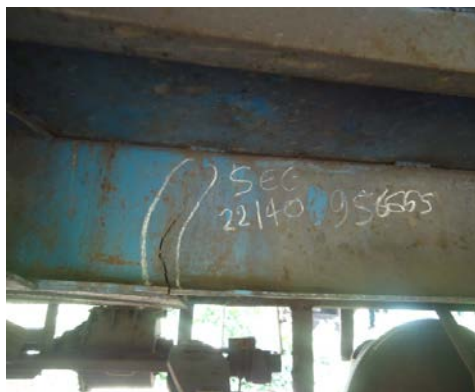
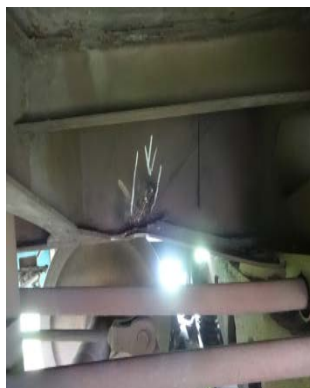
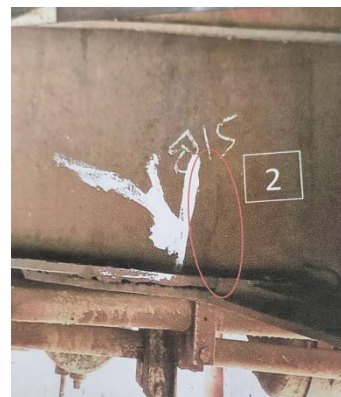
Railways/Workshops/ROH depots have reported cracks in centre-sill of BOXNHL wagons. The cracks in centre sill are categorized as under:

3.9.1.1 Repair procedure of Three piece Centre sill:

The repair procedure no WD-16002-S-01 (latest alt.) for cracks in three-piece centre sill has been prepared and circulated to all Zonal Railways vide letter no MW/BOXNHL dated 21.11.2017.

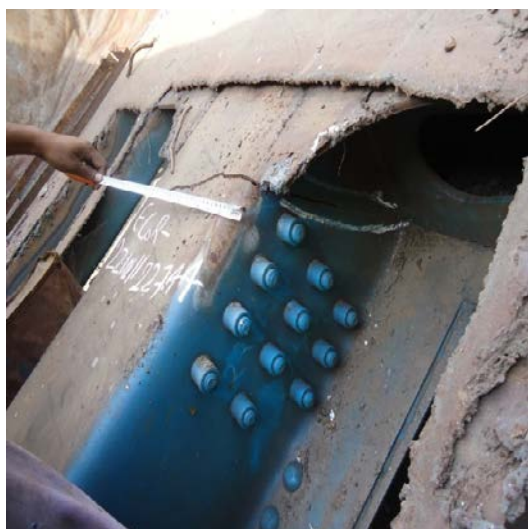
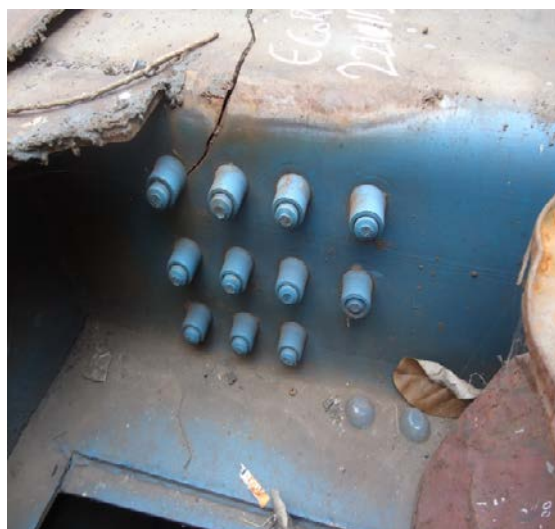
Cracks in Single piece centre sill are categorized as under:

- Between bolster and headstock near back stop lock bolt location.
- Some cases reported between bolsters at the location where stiffening plate end

3.9.2.1 Repair procedure of Single piece CRF section Centre sill:

Repair procedure nos WD-20035-S-01, WD-20035-S-02 & WD-22045-S-01 (latest alt.) of Single piece CRF section centre sill has been issued to all Zonal Railways vide letter no MW/BOXNHL dated 15.06.22

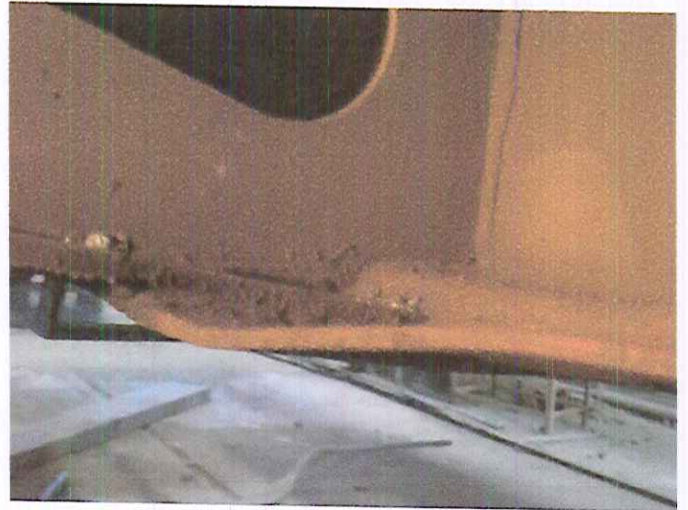
Bolster bottom flange

Centre sill flange

Recommended Procedure for repair:

- (i) Remove the bolster bottom gusset
- (ii) Maintain level at the bottom of center sill by welding a suitable thickness plate as filler and weld it to make the surface levelled.
- (iii) Weld the bolster bottom gusset as per std drawing of BOXNHL wagon.

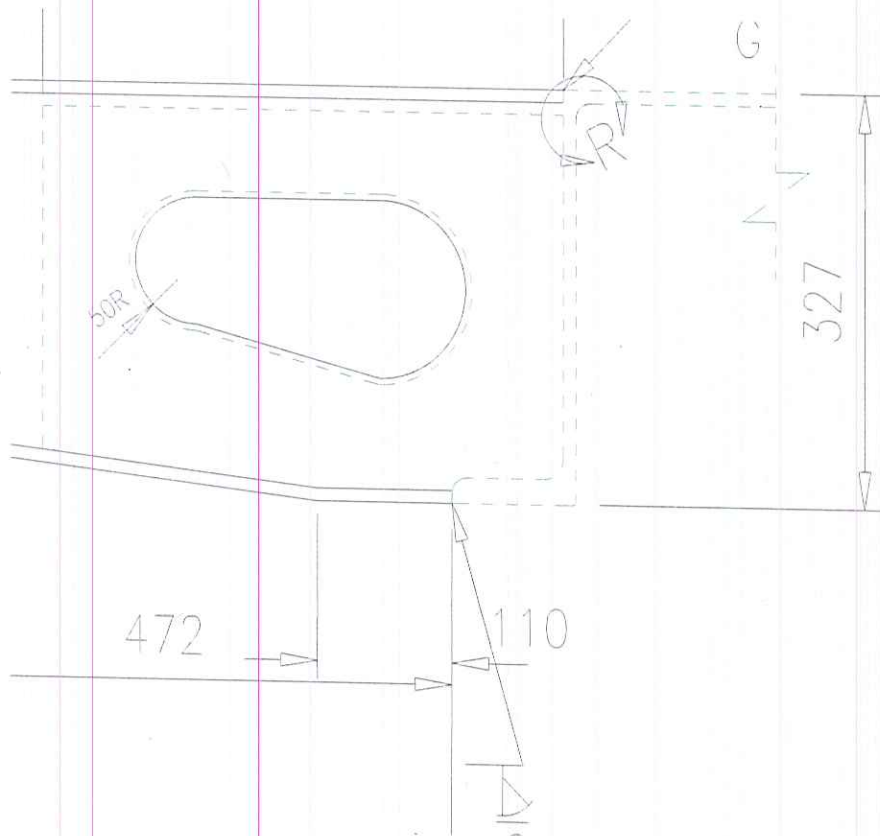
As per drg. WD-05086-S-15 (sheet-2) correct fitment of bolster bottom plate with center sill flange is appended below:

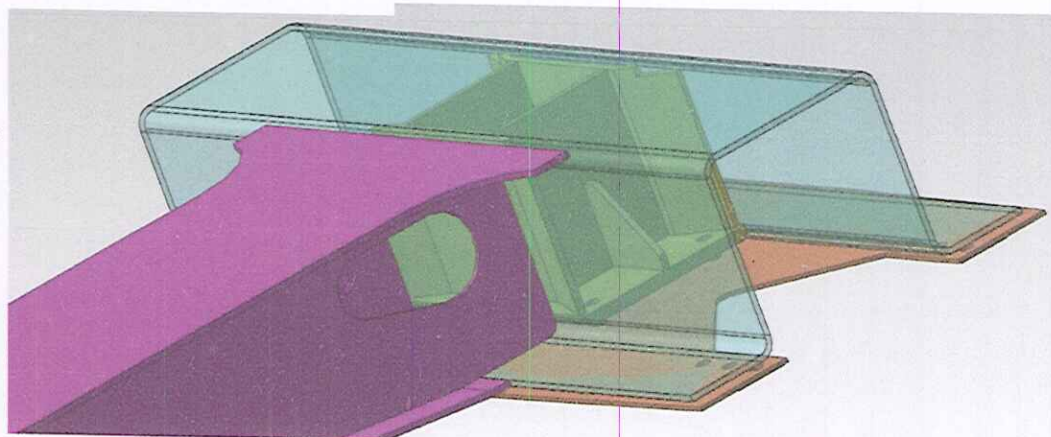
Further, as per the arrangement

shown in the drg, the bolster bottom plate should be butted flush with the centre sill flange. The bottom

gusset plate should then be welded on the face of this joint. In case, the bolster bottom plate is not flush, but protrudes inwards wrt the centre sill flange, the bottom gusset plate would get welded with a gap between the gusset plate & the bolster bottom plate. With repeated hitting of the CP top, the gusset plate is liable to first plastically deform & then subsequently crack.

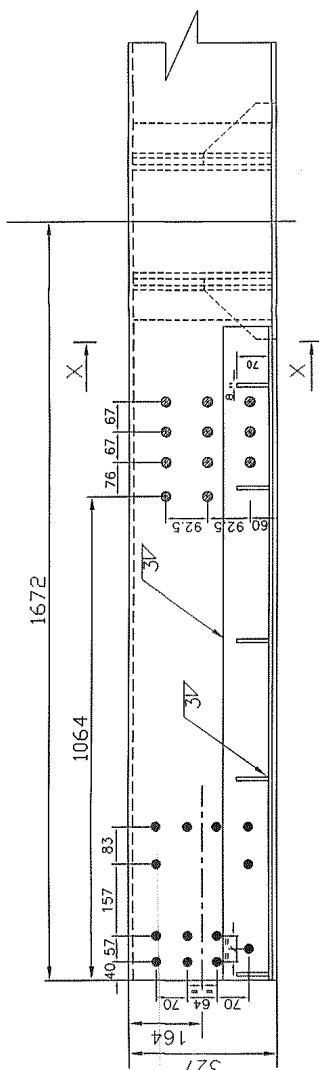
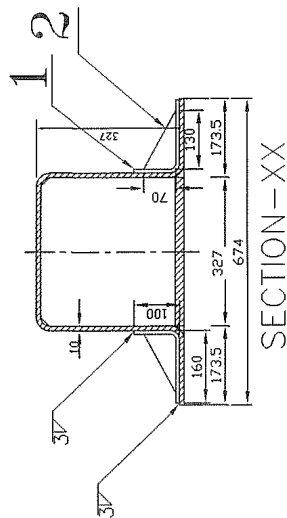
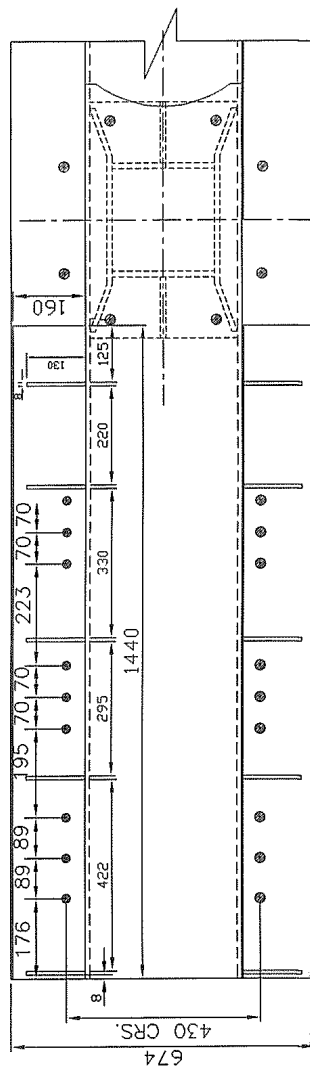
17. CENTRE SILL THUS PREPARED TO BE MARKED ON SOLEBAR PROMINENTLY AS "CENTRE SILL REPAIRED"
18. FOR PROPER MONITORING PURPOSE.
19. IN CASE TOP FLANGE OF CENTRE SILL AT THIS LOCATION HAS CRACKED ACROSS ITS WIDTH, THEN WAGON IS NOT TO BE REPAIRED.

REPAIR PROCEDURE:-

1. REMOVE FLOOR PLATE ABOVE CRACK LOCATION .
2. REMOVE COUPLER BODY AND DRAFT GEAR ASSEMBLY.
3. CHECK CENTRE SILL WEB/TOP FLANGE AT BACK STOP/DRAFT GEAR LOCATION COMPLETELY FOR ANY CRACKS THEREAFTER CHECK THE DEPTH UP TO WHICH CRACK HAS PROPAGATED.

4. REMOVE LOCK BOLTS OF BACK STOP AND STRIKER CASTING AS SHOWN IN DRAWING.
5. ARREST HOLES TO BE MADE AT END OF THE CRACKS TO PREVENT FURTHER CRACK PROPAGATION.

6. NEXT GAUGE THE CRACKS AND FILL WITH WELD FOLLOWED BY GRINDING.
7. ANGLE TO BE FABRICATED AS PER DETAILS SHOWN IN DRAWING.
8. TO WELD RIBS WITH ANGLE AS PER SPECIFIED DISTANCES GIVEN IN DRAWING.

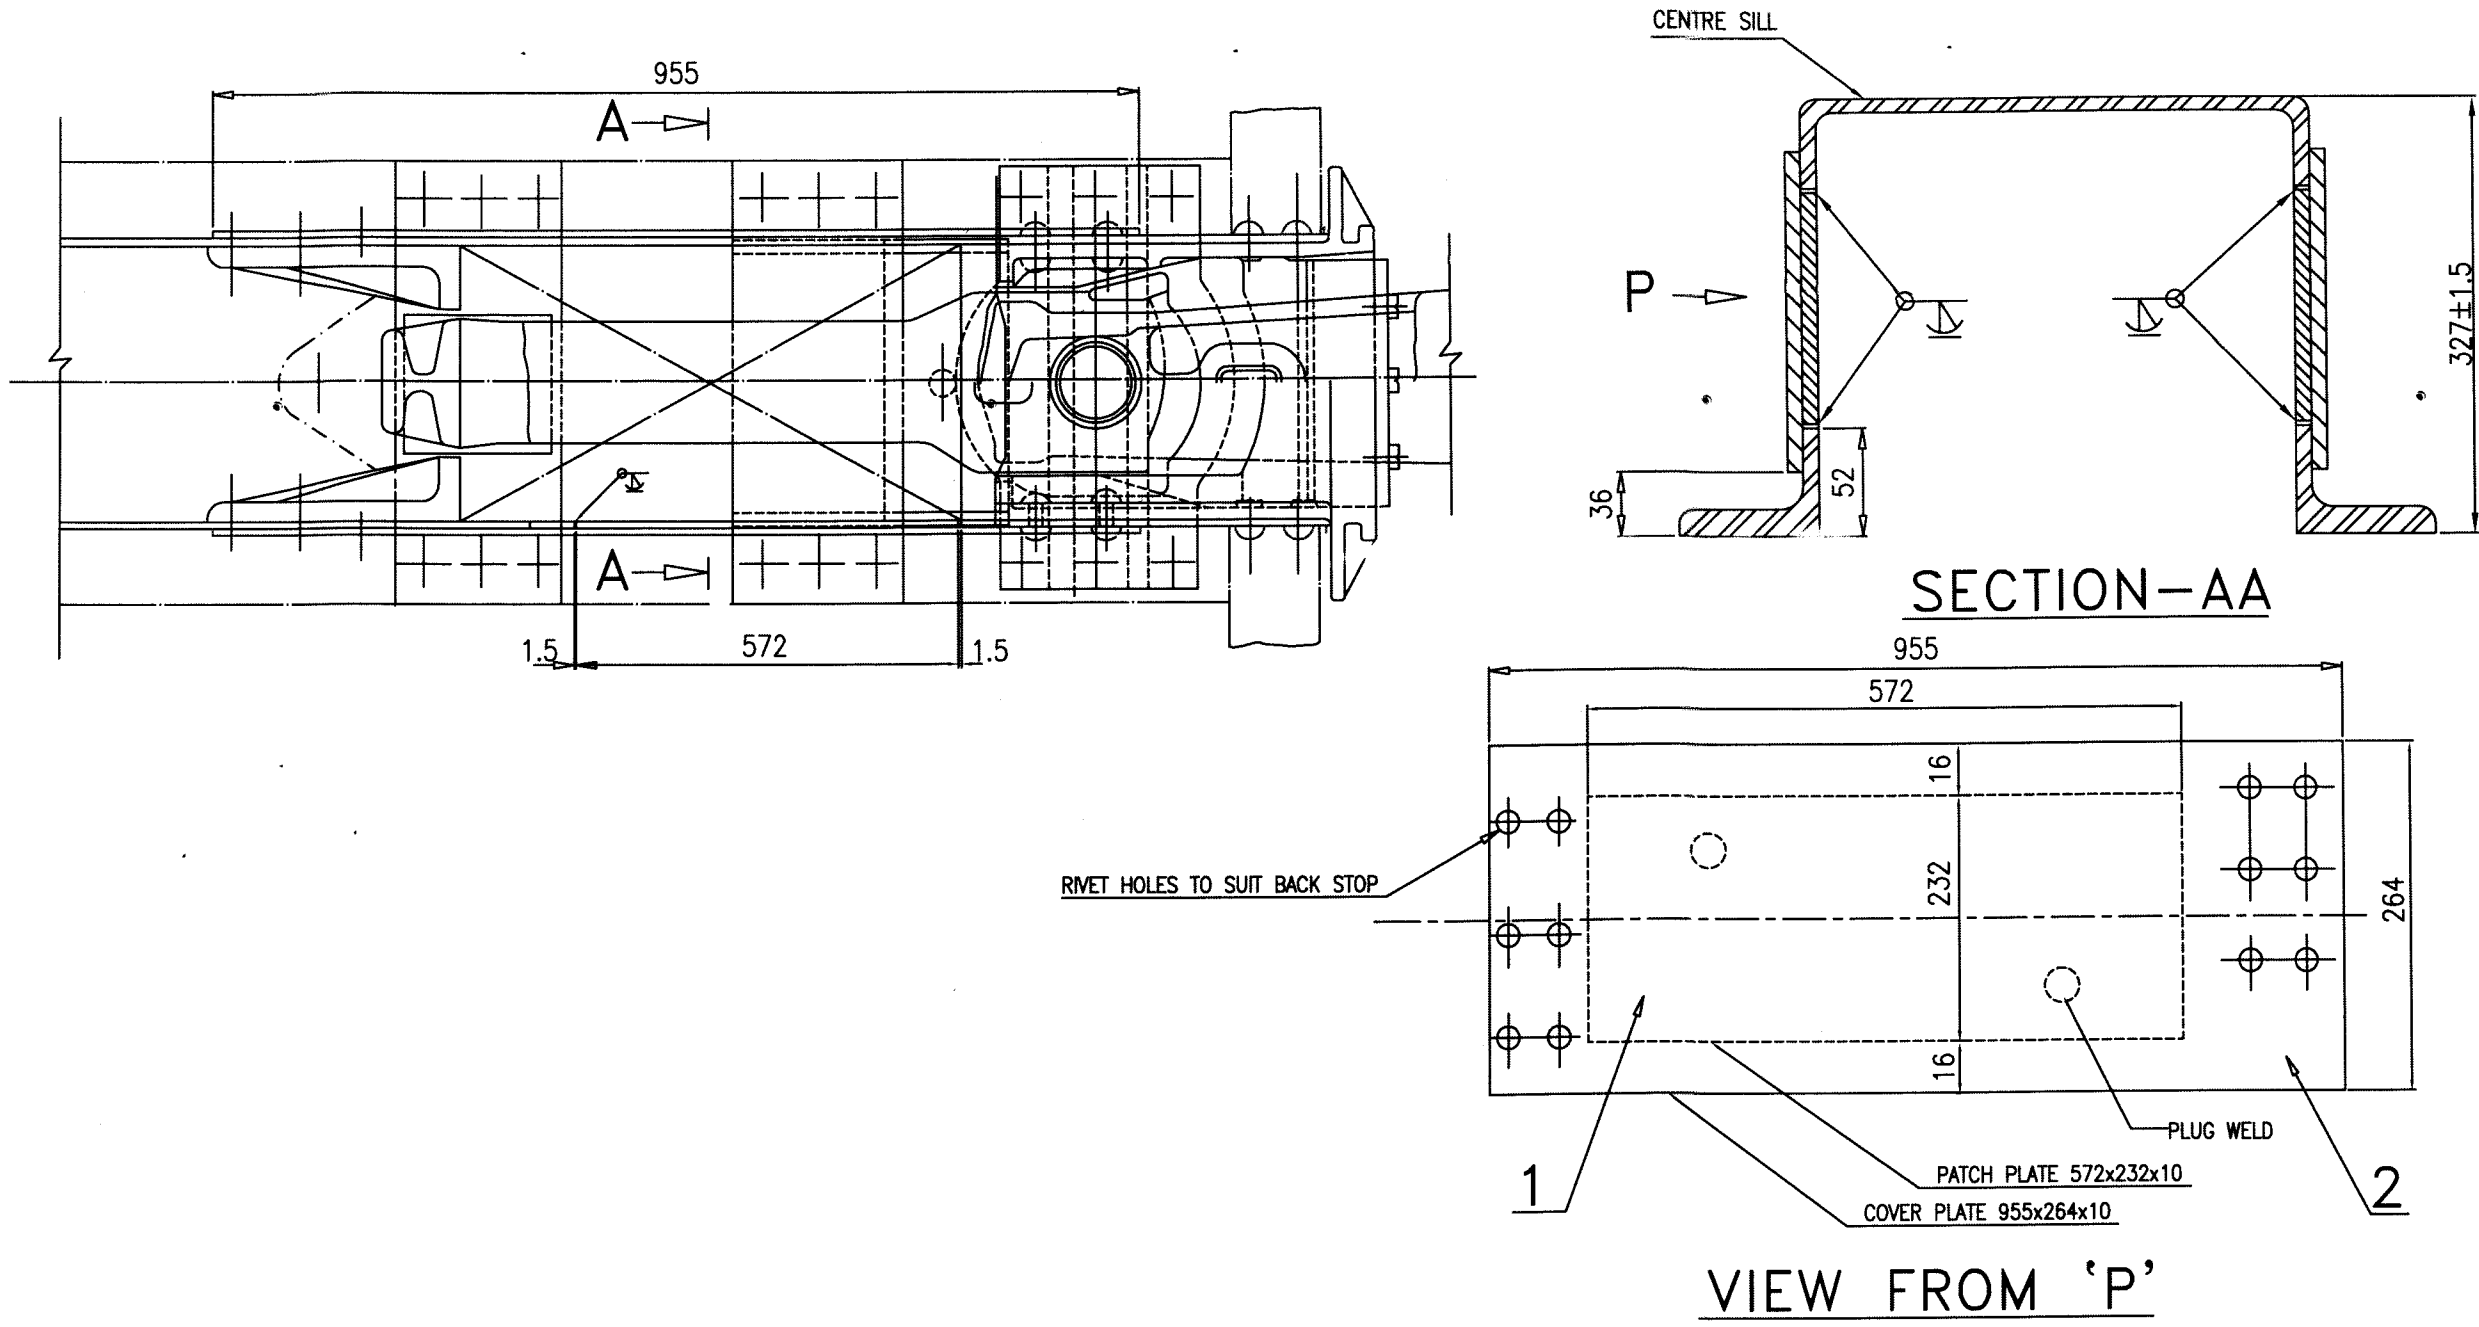
1. REMOVE COUPLER BODY AND DRAFT GEAR ASSEMBLY.
2. CHECK CENTRE SILL SIDE WALL AT DRAFT GEAR LOCATION COMPLETELY FOR ANY DAMAGE/BULGING IF FOUND SUCH DEFECT . STANDARD PATCHING REPAIR IS REQUIRED.

REPAIRE PROCEDURE:-

3. CUT RIVETS OF TWO COLUMN OF BACK STOP AND STRIKER CASTING AS SHOWN IN DRAWING.
4. CUT A WINDOW ON SIDE WALL OF CENTRE SILL OF 575X235 COVERING EFFECTED / DAMAGED SIDE WALL OF CENTRE SILL AND REMOVED IT COMPLETELY.
